# Wetting and Drying Performance and On-site Moisture Protection of Nail-Laminated Timber Assemblies

June 2016

Jieying Wang, Senior Scientist, Advanced Building Systems

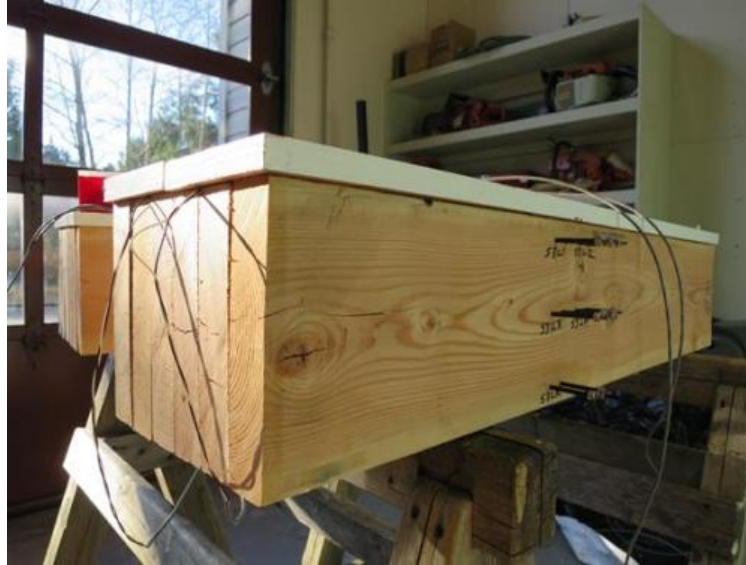
**Figure 1** A nail-laminated timber assembly being instrumented in the laboratory

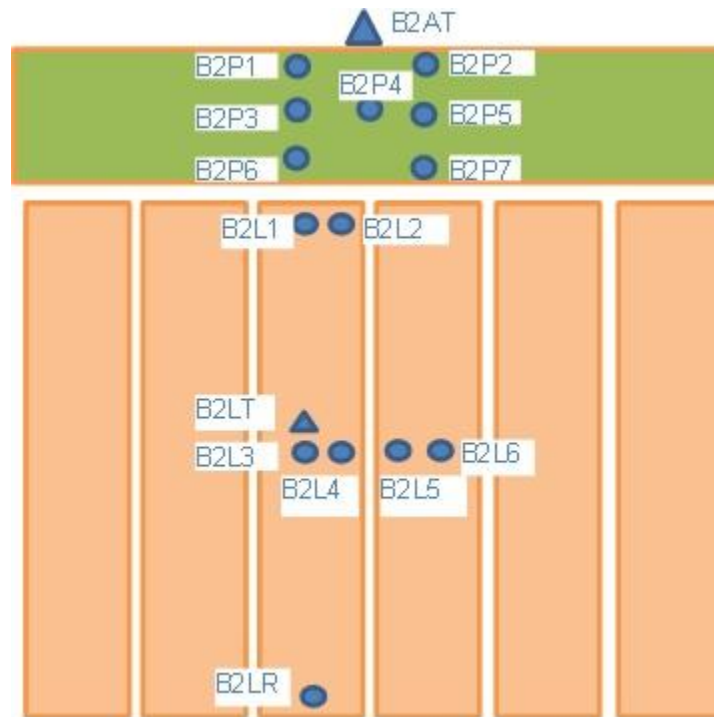
**Figure 2 Sensors in central cross section of nail-laminated timber and plywood sheathing as installed in test assembly B2 of Group 3**

Note: All sensors were moisture pin sensors except temperature sensors of B2LT and B2AT. Regarding the labels, “B2” indicates the specimen number, “L” means the sensor is in boards of NLT, “P” means it is in plywood, and the last number in each label indicates the location. The letters and numbers in each label are consistent among all specimens.

Relatively more sensors were used to instrument the beam and the plywood of each test assembly of Group 3 before the laboratory wetting (Figure 2, see Section 4.3 for more details). Each beam was instrumented with the package of seven moisture sensors and one temperature sensor. For each of the 5-ply plywood sheathing, moisture sensors, also in a total of seven, were installed in the middle and the two surface layers to detect MC changes at different locations during the drying process. The moisture sensors were inserted into the plywood from the bottom surface to avoid penetration in the top surface;

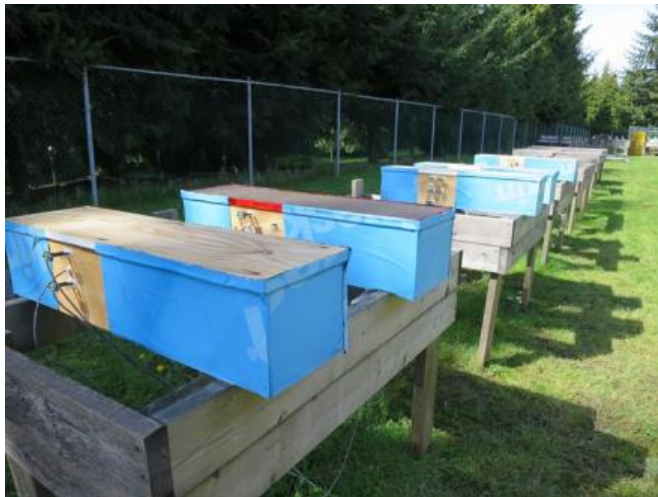
**Figure 3** Test assemblies under outdoor exposure at FPInnovations' Vancouver laboratory

Each specimen was oriented as a small deck during the wetting and drying processes. Efforts were made to ensure that moisture would primarily move (i.e., wetting or drying) only across the depth of each assembly. The four edges of each plywood panel were sealed by applying two-part epoxy before wetting to simulate larger panels and to minimize edge effects. The edges of each NLT beam, except for small areas used for installing sensors, and the interface with the sheathing above were all sealed using impermeable membranes and tapes (see Figure 3).

Test assemblies from Group 1 were placed on shelves exposed to exterior conditions, starting at the end of February, 2015 (Figure 3; see Section 4.4 for description about the additional field exposure test). See App-Figure 1 and App-Table 1 (Appendix II) for information on the number of days of rain and precipitation amounts. Rainfall mostly occurred in the spring, fall and winter with a total precipitation of about 1037 mm from March 2015 to January 2016. The summer turned out to be drier than normal, with little or no rain from May to August. An RH/T sensor (HOBO, EL-USB-2-LCD RH/TEMP data logger) was used to measure the ambient temperature and relative humidity (RH) under a test assembly, with the RH and temperature readings shown in App-Figure 2 (Appendix II). There

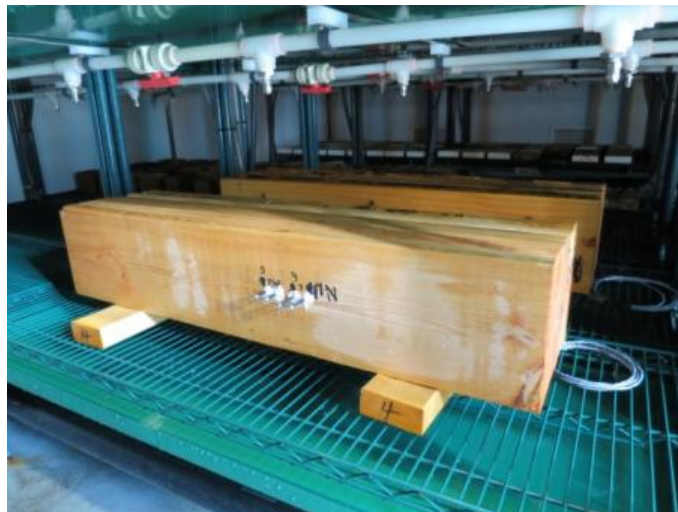
**Figure 4** Nail-laminated timber specimens being wetted by controlled spray of water in the laboratory

The assembled specimens of Group 2 and the individual beam and plywood of Group 3 were wetted under controlled spray of water in the laboratory to simulate a severe wetting scenario caused by rain at a construction site. They were placed on shelves under spray nozzles in a facility at FPInnovations Vancouver laboratory (Figure 4). At a temperature of 20°C, the RH was controlled at about 90% to prevent drying from wetted specimens. The wetting procedure included hourly spray of water for approximately 18 days<sup>1</sup>, with each spray lasting 5 seconds. It was estimated that about 80 litres of water in total was sprayed on each specimen, roughly equivalent to a rainfall of about 350 mm.

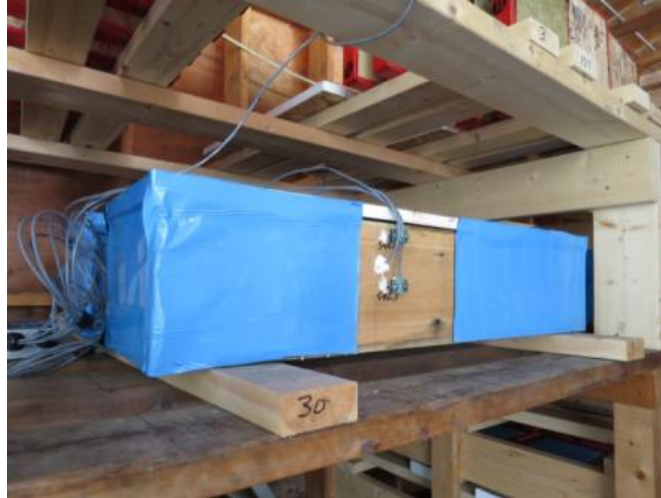
**Figure 5** Nailed-laminated timber assemblies undergoing drying in the shed after laboratory wetting

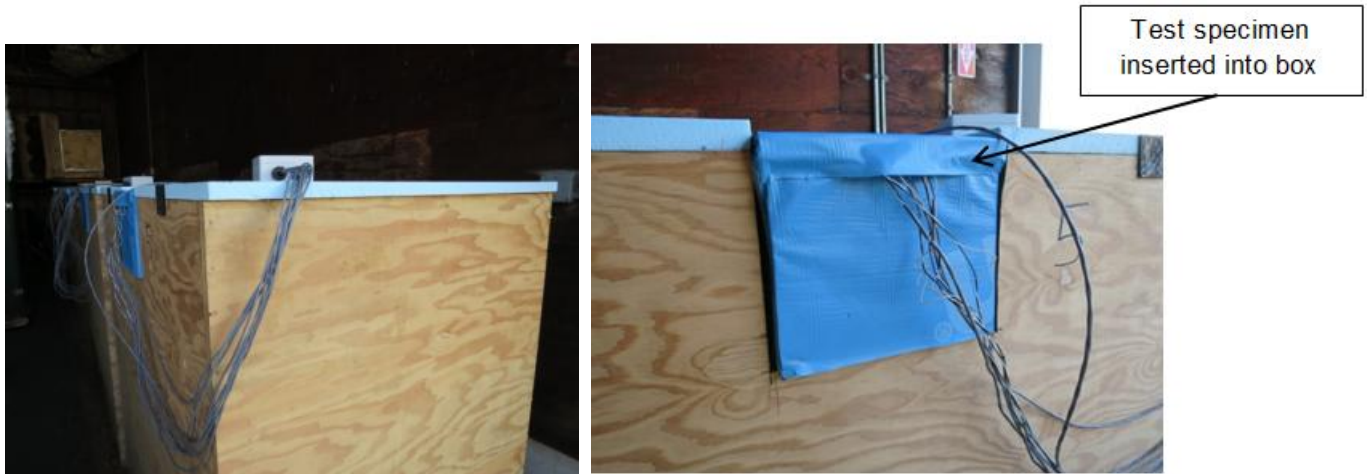
**Figure 6** Nail-laminated timber assemblies undergoing drying above plywood boxes in the shed

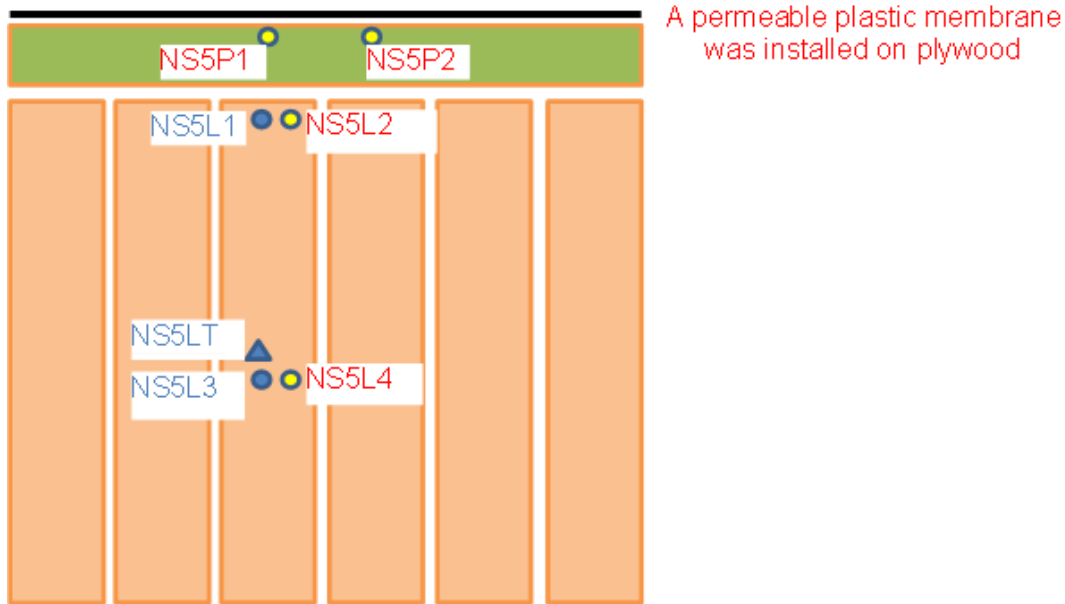
**Figure 7** Sensors in central cross section of nail-laminated timber and plywood sheathing as installed in test assembly NS5 based on those in the original assembly S5

Note: Sensors with labels in red were added during modification for the additional outdoor exposure

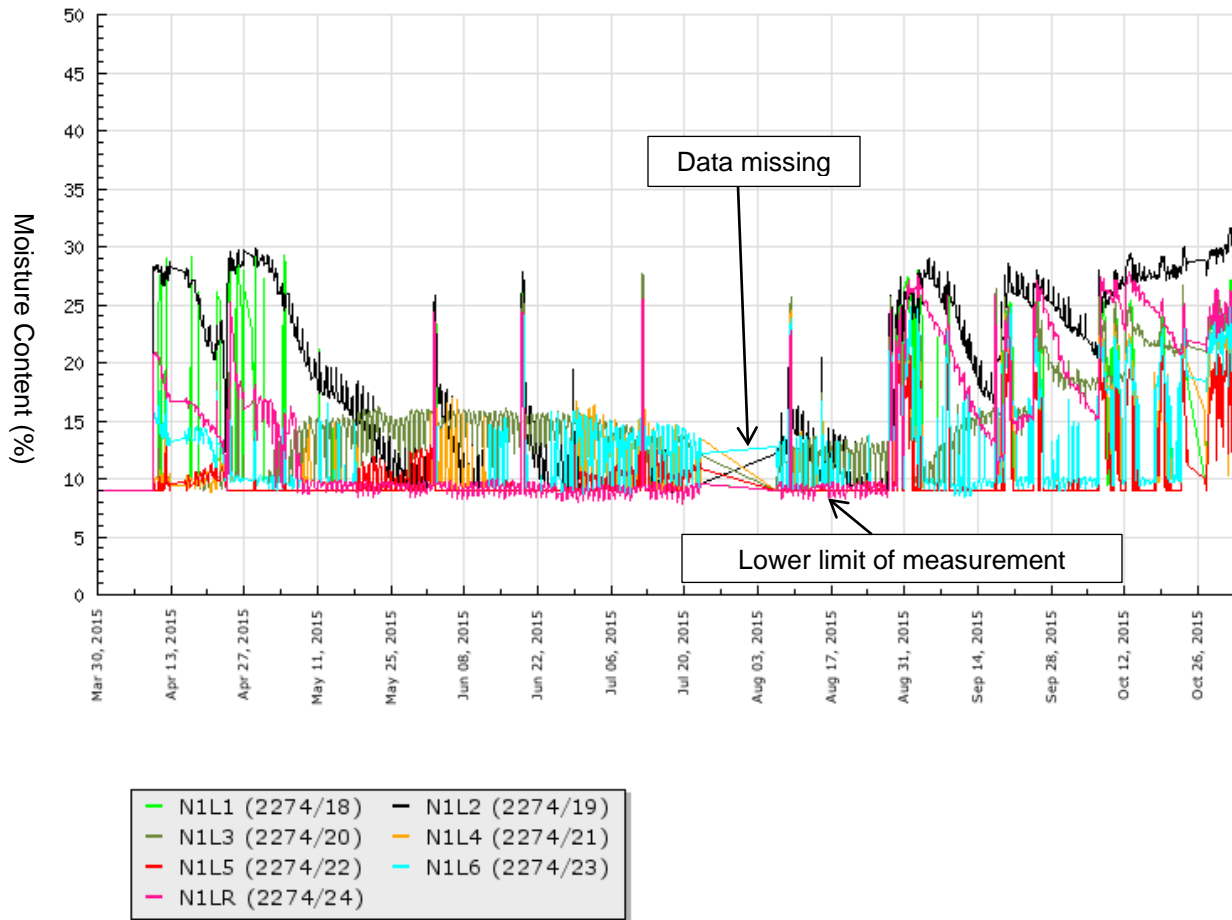
**Figure 8** Moisture content readings from sensors installed in N1 beam without sheathing on top

Note: L—boards of NLT; number after “L”: 1, 2—top surface; 3, 4, 5, 6—central; R—bottom

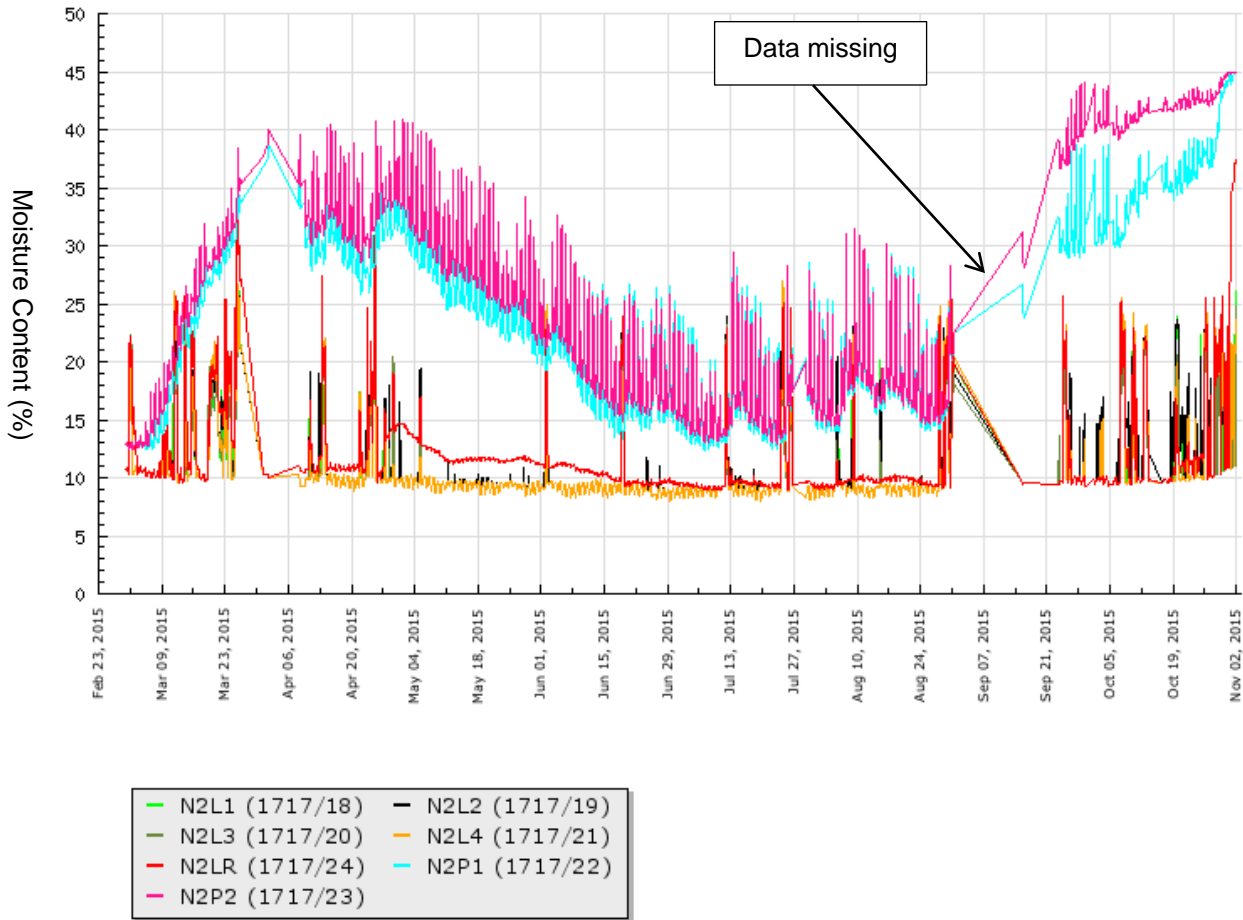
**Figure 9 Moisture content readings from sensors installed in N2 beam and plywood sheathing**

Note: L—boards of NLT; number after “L”: 1, 2—top surface; 3, 4, 5, 6—central; R—bottom  
 P—plywood; P1, P2—middle layer of plywood

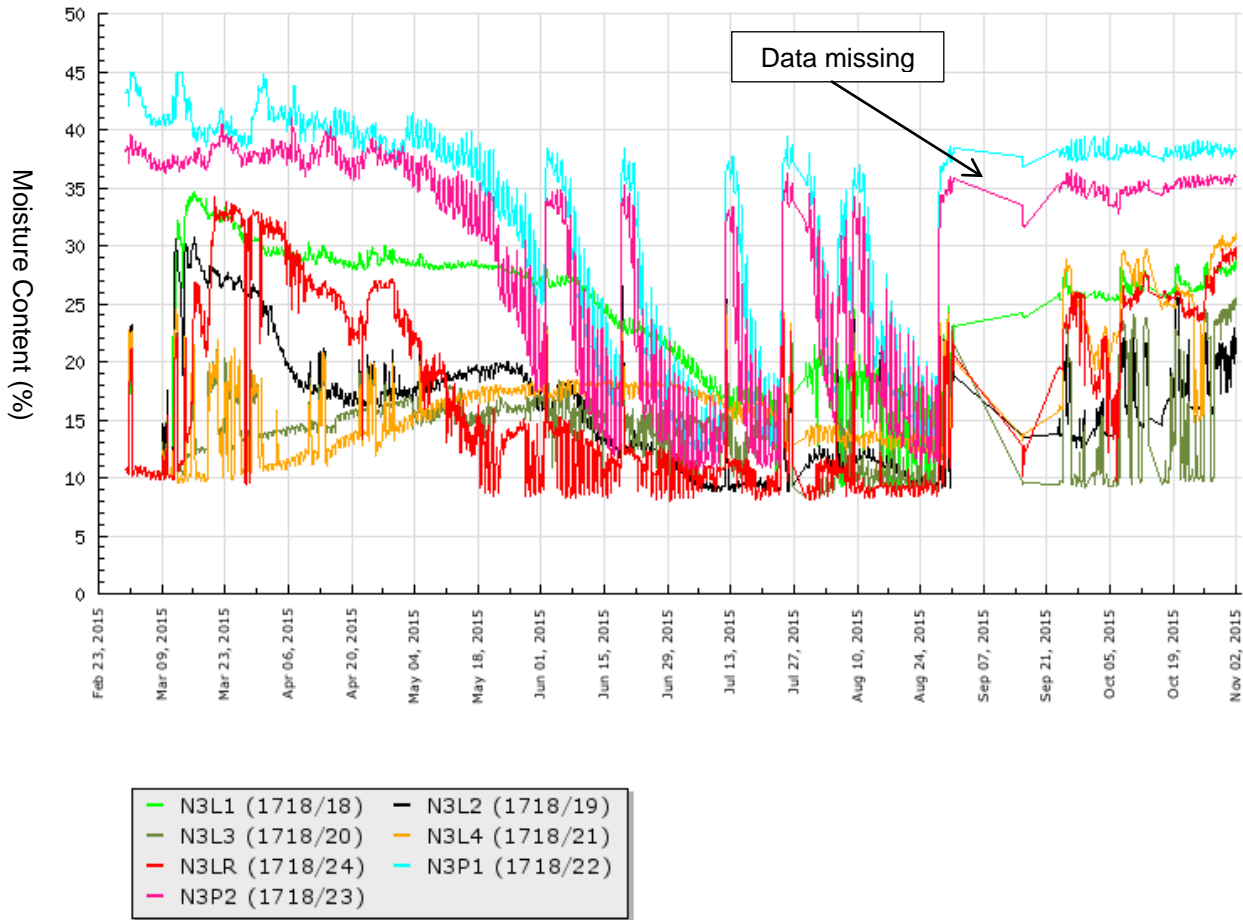
**Figure 10 Moisture content readings from sensors installed in N3 beam and plywood sheathing with a gap in the sheathing**

Note: L—boards of NLT; number after “L”: 1, 2—top surface; 3, 4, 5, 6—central; R—bottom  
 P—plywood; P1, P2—middle layer of plywood

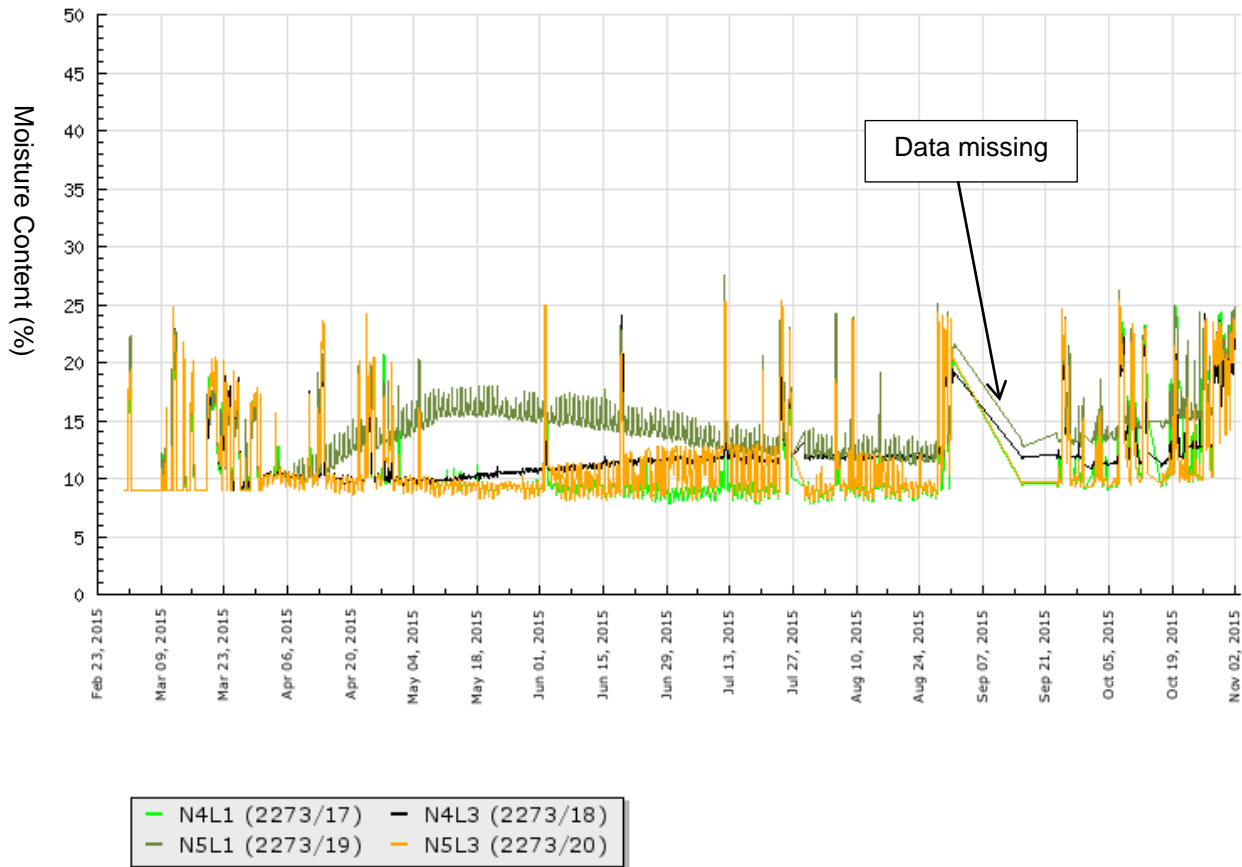
**Figure 11 Moisture content readings from sensors installed in N4 and N5 beams**

Note: L—boards of NLT; number after “L”: 1—top surface; 3—central

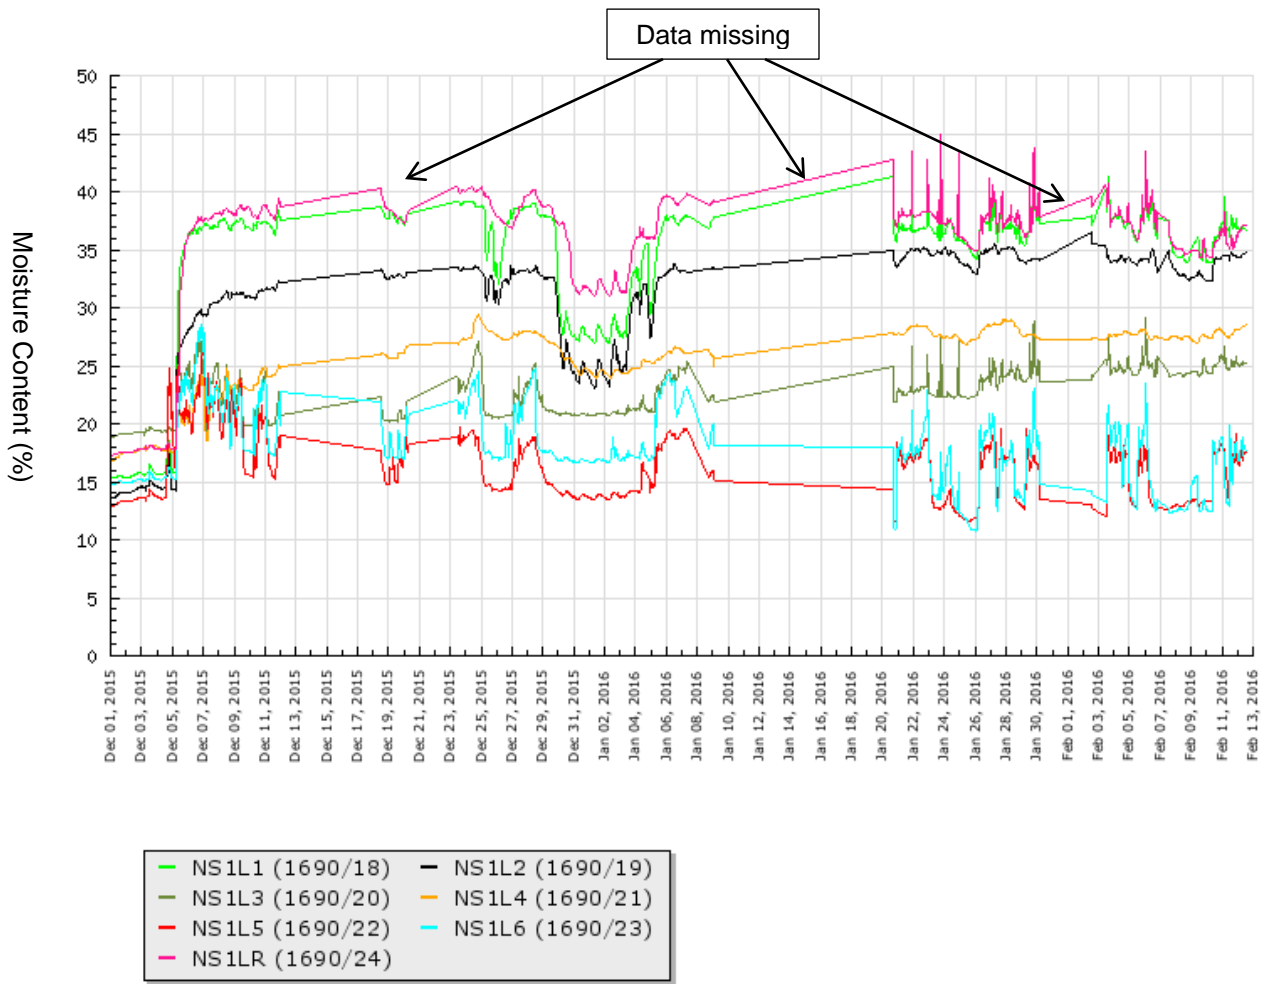
Figure 12 Moisture content readings from sensors Installed in NS1 beam without sheathing on top

Note: L—boards of NLT; number after “L”: 1, 2—top surface; 3, 4, 5, 6—central; R—bottom

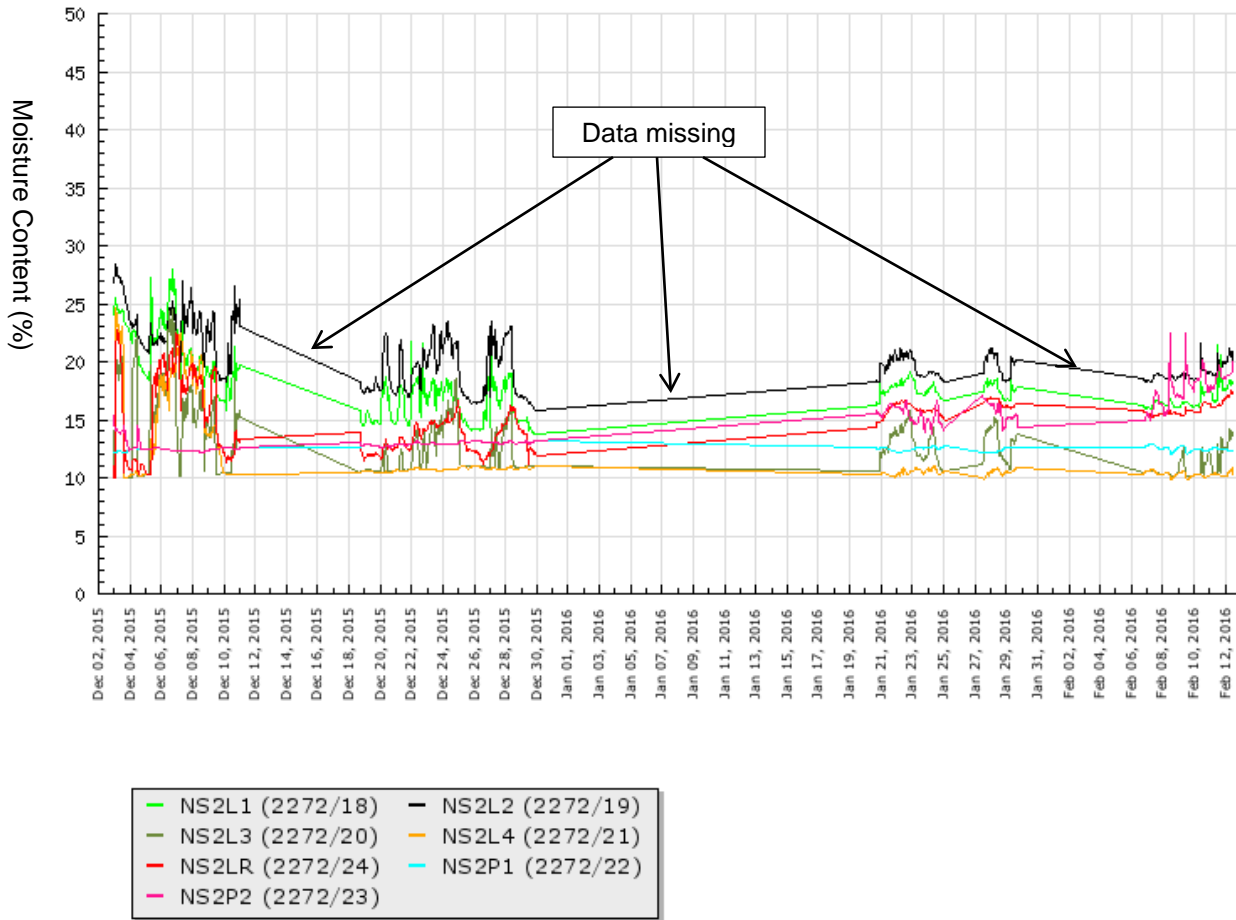
**Figure 13 Moisture content readings from sensors installed in assembly NS2 with an impermeable membrane on the top**

Note: L—boards of NLT; number after “L”: 1, 2—top surface; 3, 4—central; R—bottom  
 P—plywood; P1, P2—top surface of plywood

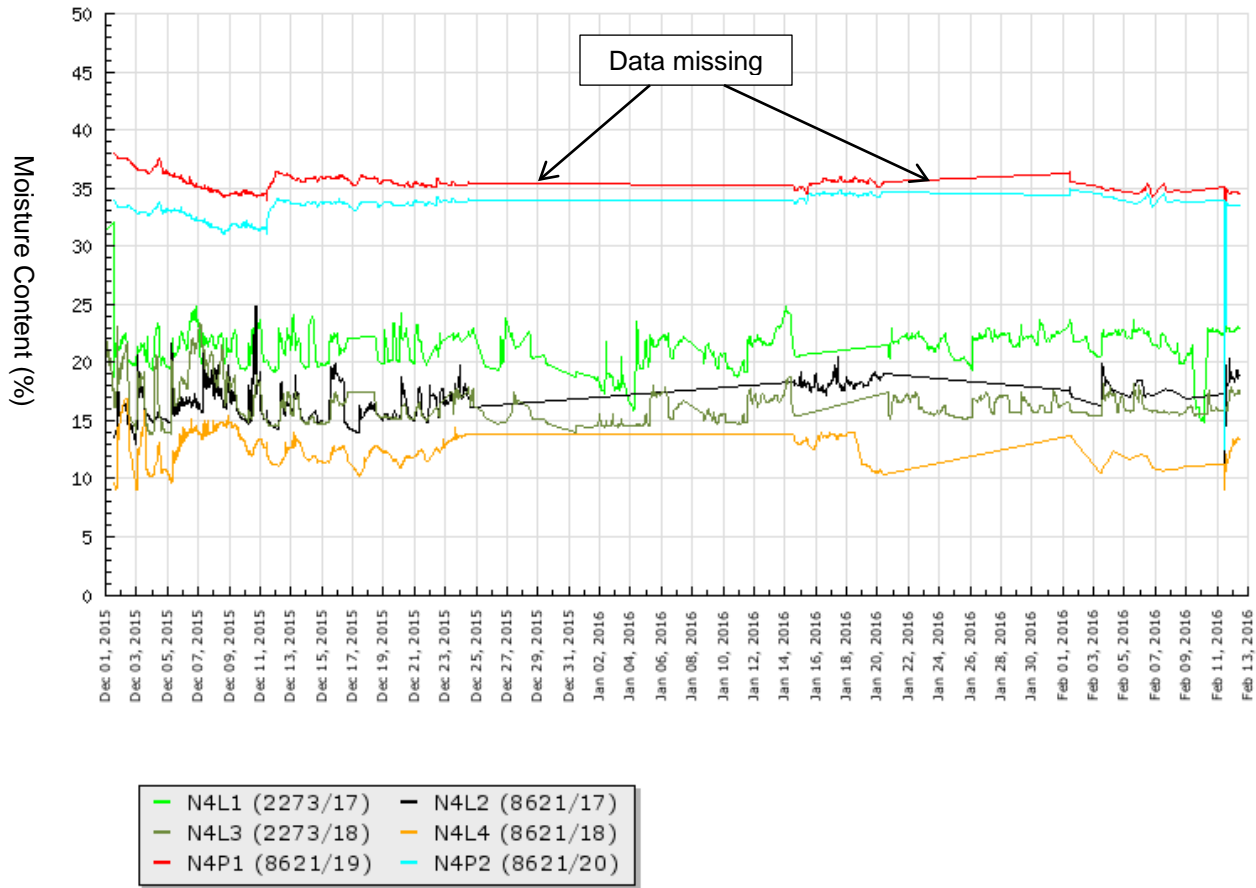
**Figure 14 Moisture content readings from sensors installed in assembly N4 with building paper between beam and plywood**

Note: L—boards of NLT; number after “L”: 1, 2—top surface; 3, 4—central  
 P—plywood; P1, P2—top surface of plywood

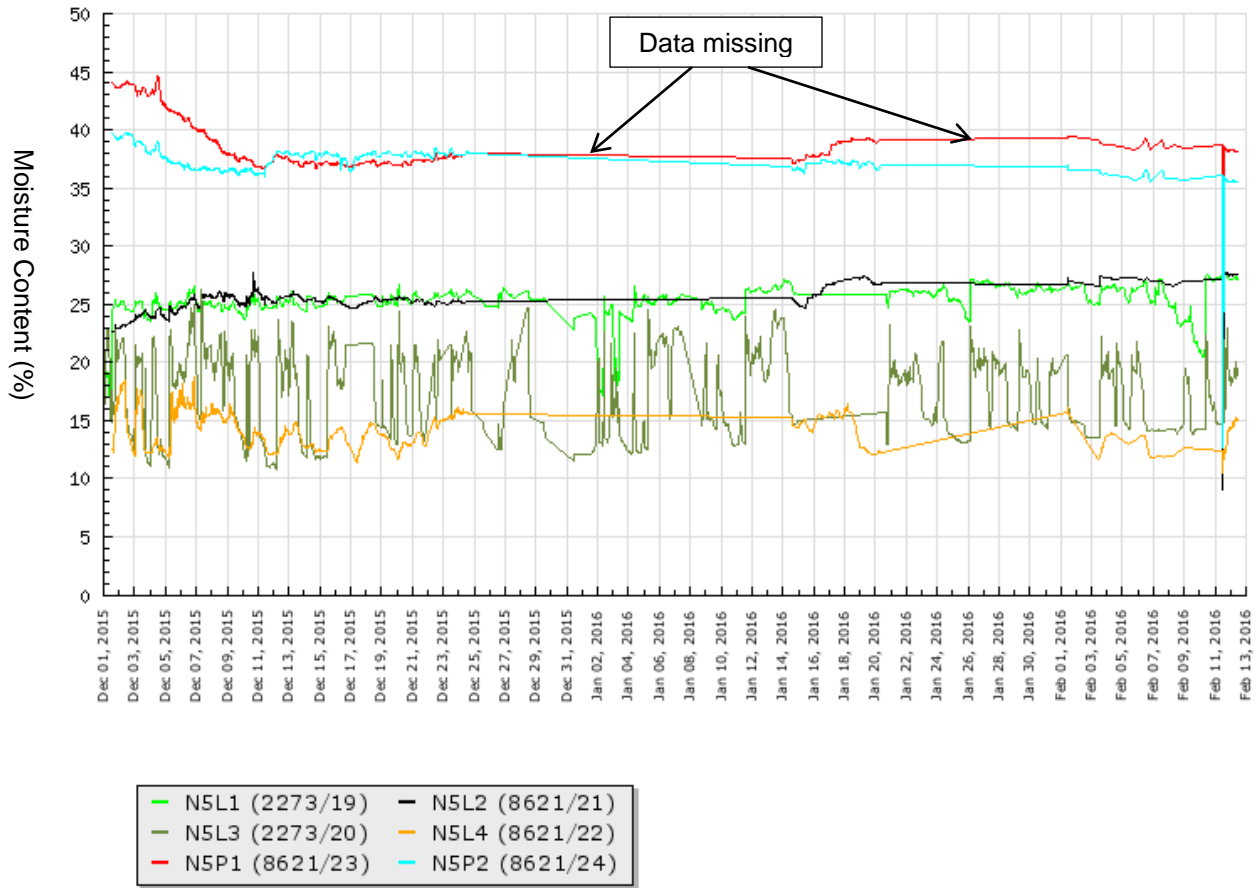
**Figure 15 Moisture content readings from sensors installed in assembly N5 with building paper above plywood**

Note: L—boards of NLT; number after “L”: 1, 2—top surface; 3, 4—central  
 P—plywood; P1, P2—top surface of plywood

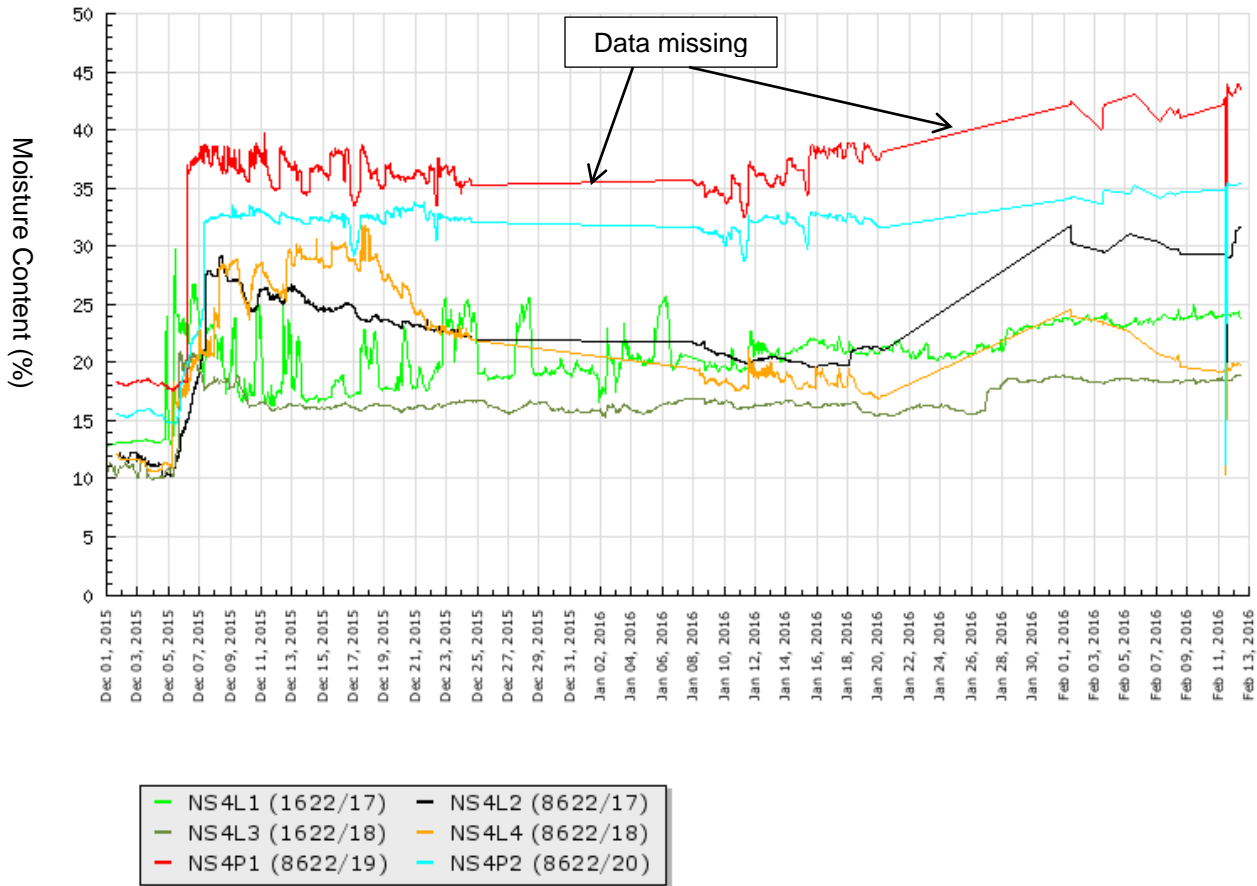
**Figure 16 Moisture content readings from sensors installed in assembly NS4 with a permeable membrane between beam and plywood**

Note: L—boards of NLT; number after “L”: 1, 2—top surface; 3, 4—central  
 P—plywood; P1, P2—top surface of plywood

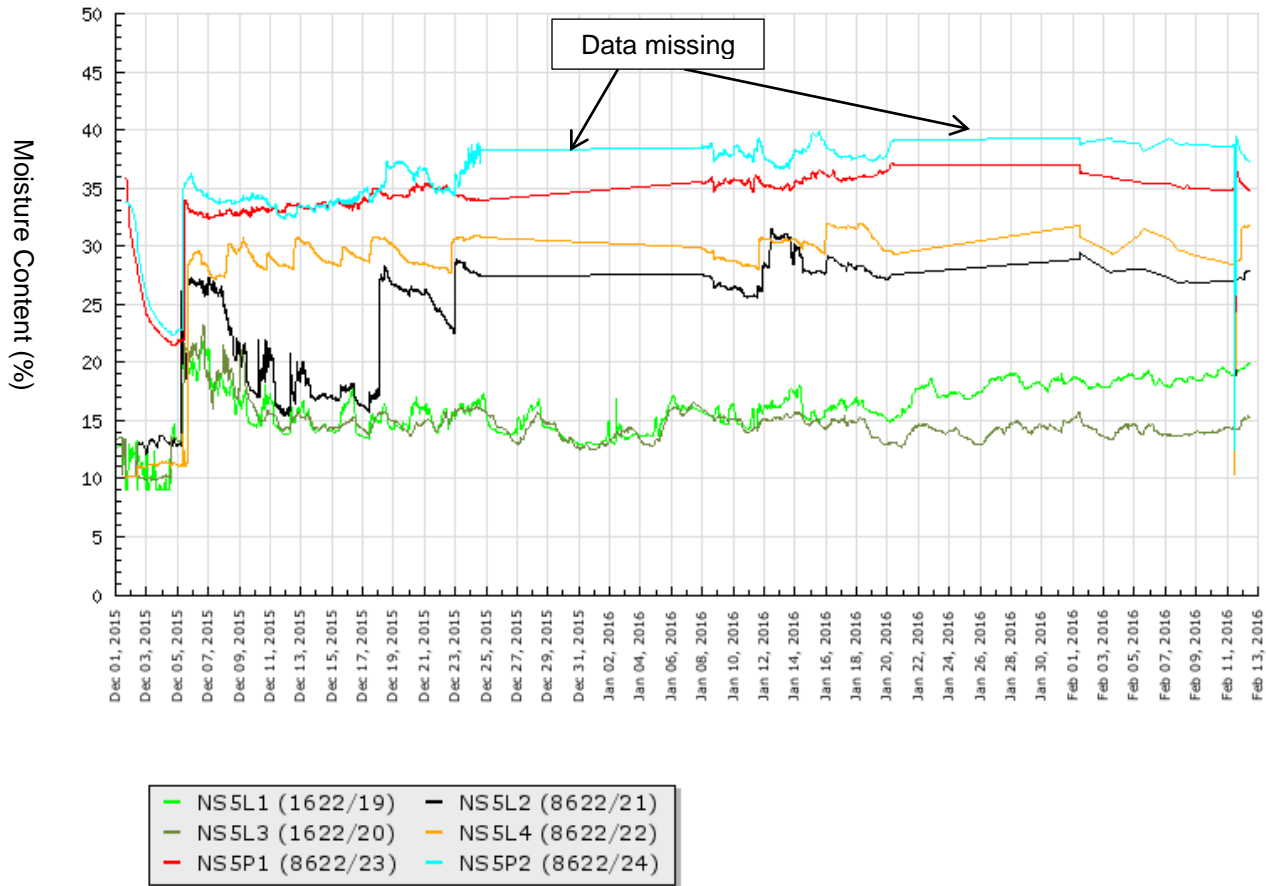
**Figure 17** Moisture content readings from sensors installed in assembly NS5 with a permeable membrane above plywood

Note: L—boards of NLT; number after “L”: 1, 2—top surface; 3, 4—central  
 P—plywood; P1, P2—top surface of plywood

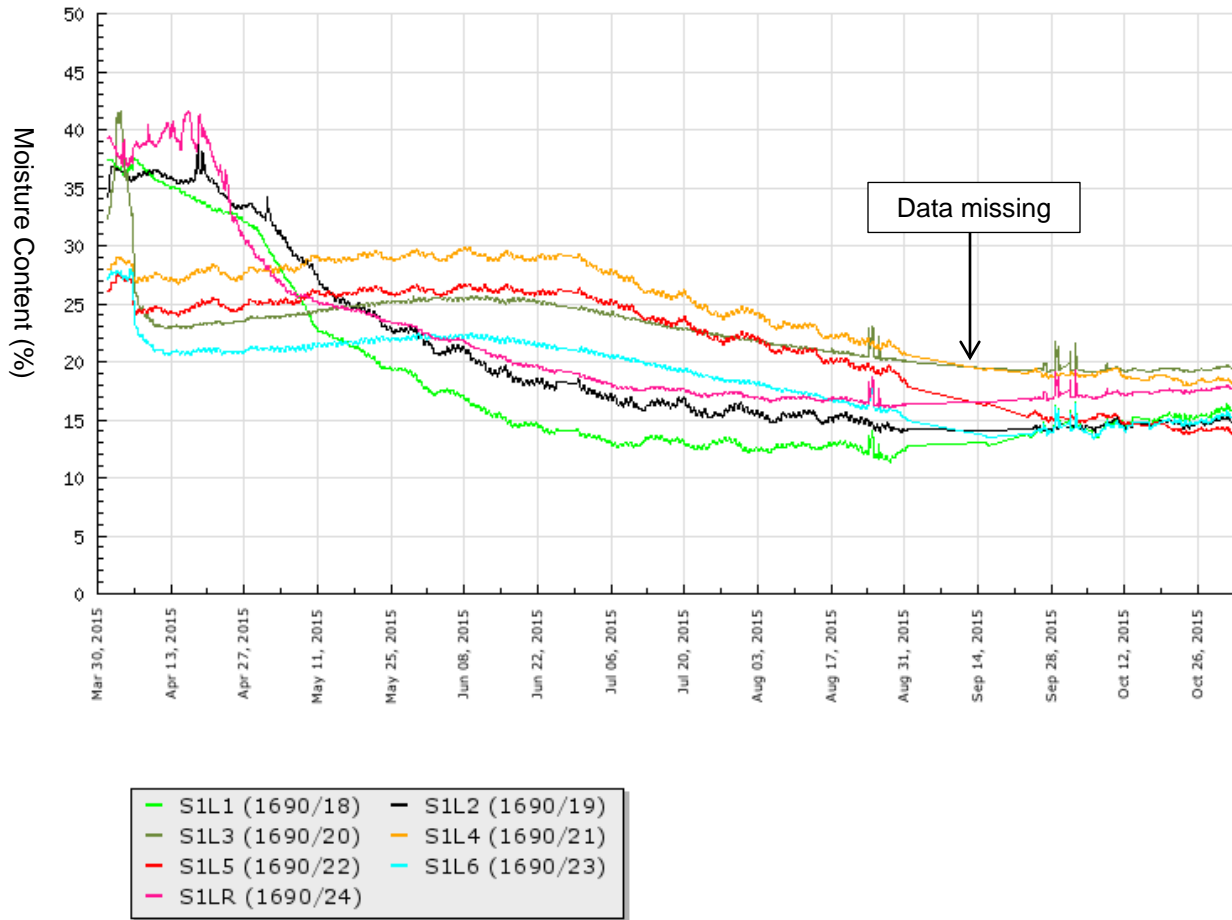
**Figure 18** Moisture content readings from sensors installed in S1 beam without sheathing on top

Note: L—boards of NLT; number after “L”: 1, 2—top surface; 3, 4, 5, 6—central; R—bottom

The wetting scheme used in the laboratory through controlled spray of water was more intense than the natural wetting during the outdoor exposure. For an unprotected NLT beam (i.e., S1, Figure 18), the sensors installed in the surface of NLT showed MCs over 40%, indicating that these locations were very wet and may be beyond the upper measurement limit, when the drying test started in the shed. Measurements from those locations suggested the NLT beam dried relatively quickly under the sheltered conditions and the MCs reached 20% after about two months. However, the central measuring locations showed MCs close to 30% at the beginning; moreover, the MC stayed high for an extensive period of time. They slowly dropped to 20% at the end of August, five months into the drying test after a drier than normal summer. This might have led to decay but the specimen was not opened for inspection.

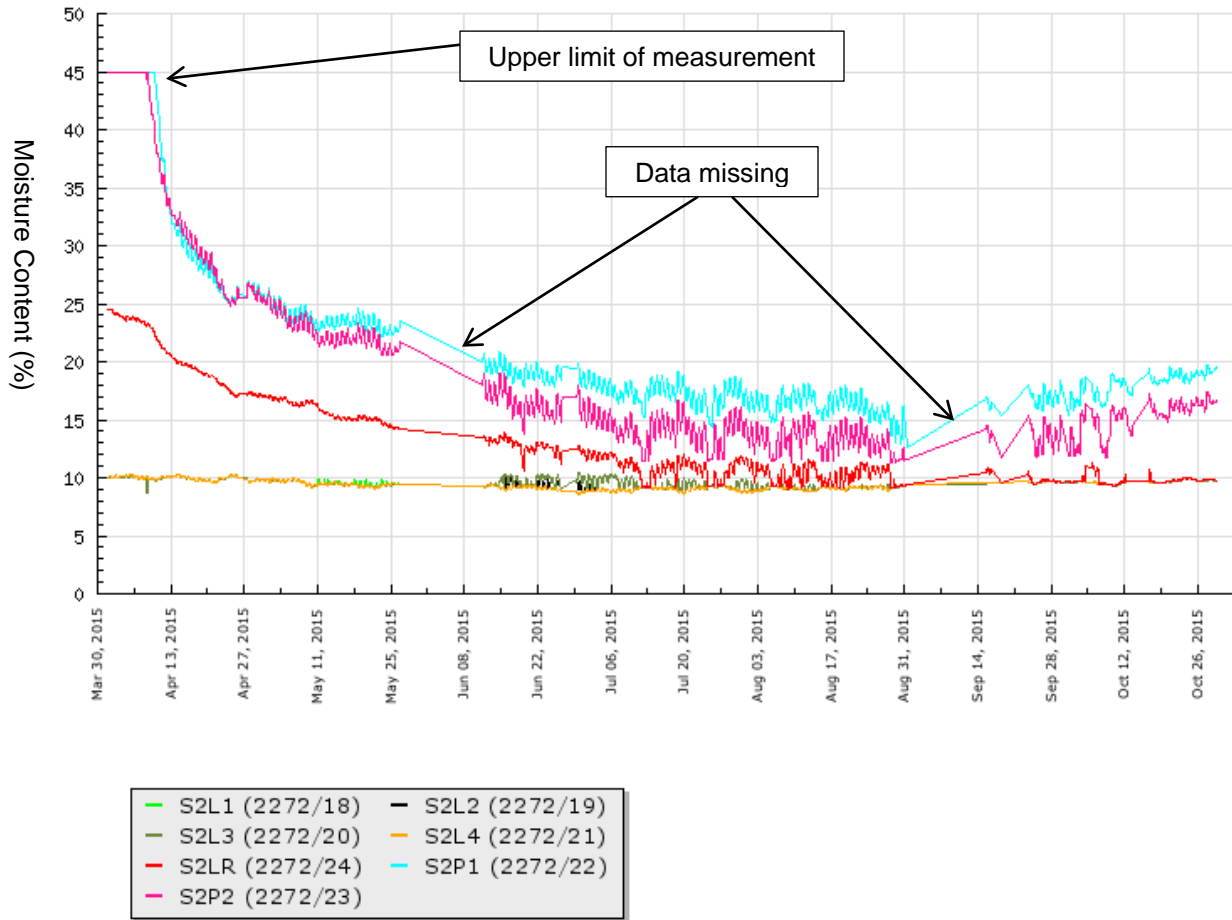
**Figure 19 Moisture content readings from sensors installed in S2 beam and plywood sheathing**

Note: L—boards of NLT; number after “L”: 1, 2—top surface; 3, 4—central; R—bottom  
 P—plywood; P1, P2—middle layer of plywood

When there was plywood sheathing on the top (i.e., S2, Figure 19), the NLT beam stayed relatively dry except for a measuring location in the bottom surface, which could have been wetted by water dripping or splashing. Nevertheless, this location dried relatively quickly. The plywood showed very high MCs, exceeding the upper limit of 45% of the MC measurement system after the laboratory wetting procedure. But it dried relatively quickly, with the MCs falling below 20% in mid-June, after about two months and a half in the shed. When there was a gap in the sheathing (Figure 20), not only the plywood itself but also the NLT beam below showed considerable wetness, similar to the results from the outdoor exposure test. It appeared that the surface of NLT immediately below the plywood was actually gaining moisture, with the MC increasing for about two months until the end of May. Some moisture could have transmitted from the moisture-saturated plywood to the solid wood below. When a layer of building paper was used for protection, either being installed between sheathing and NLT (i.e., assembly S4) or above the sheathing (i.e., S5) (Figure 21), some moisture was still able to pass the sheathing and reach the NLT below. The NLT appeared to be slightly damp with a surface (below plywood) MC around 20%. Compared to the outdoor exposure test (Section 5.1), this laboratory test appeared to better demonstrate the risk of NLT due to moisture entrapment as well as the moderate level of on-site protection that may be provided by building paper.

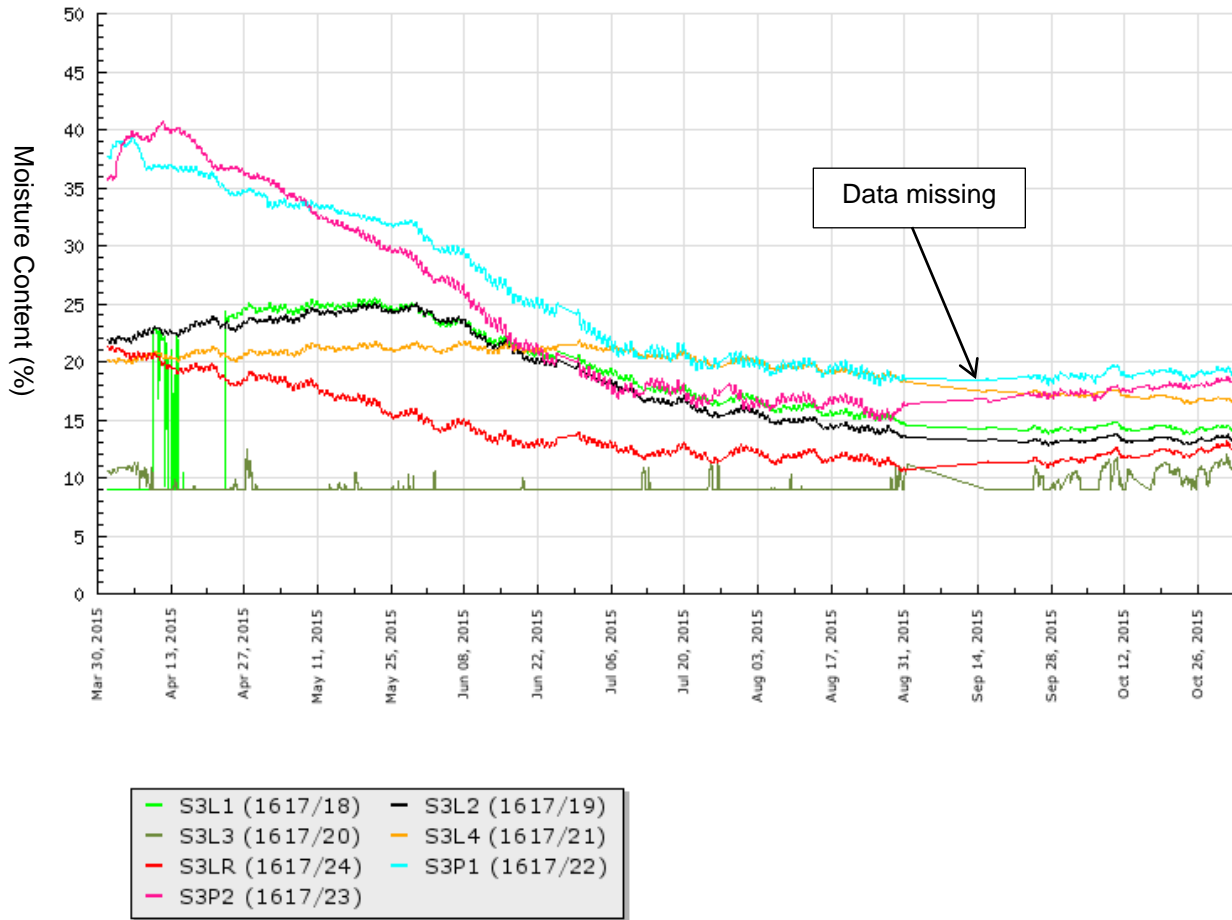
**Figure 20 Moisture content readings from sensors installed in S3 beam and plywood sheathing**

Note: L—boards of NLT; number after “L”: 1, 2—top surface; 3, 4—central; R—bottom  
 P—plywood; P1, P2—middle layer of plywood

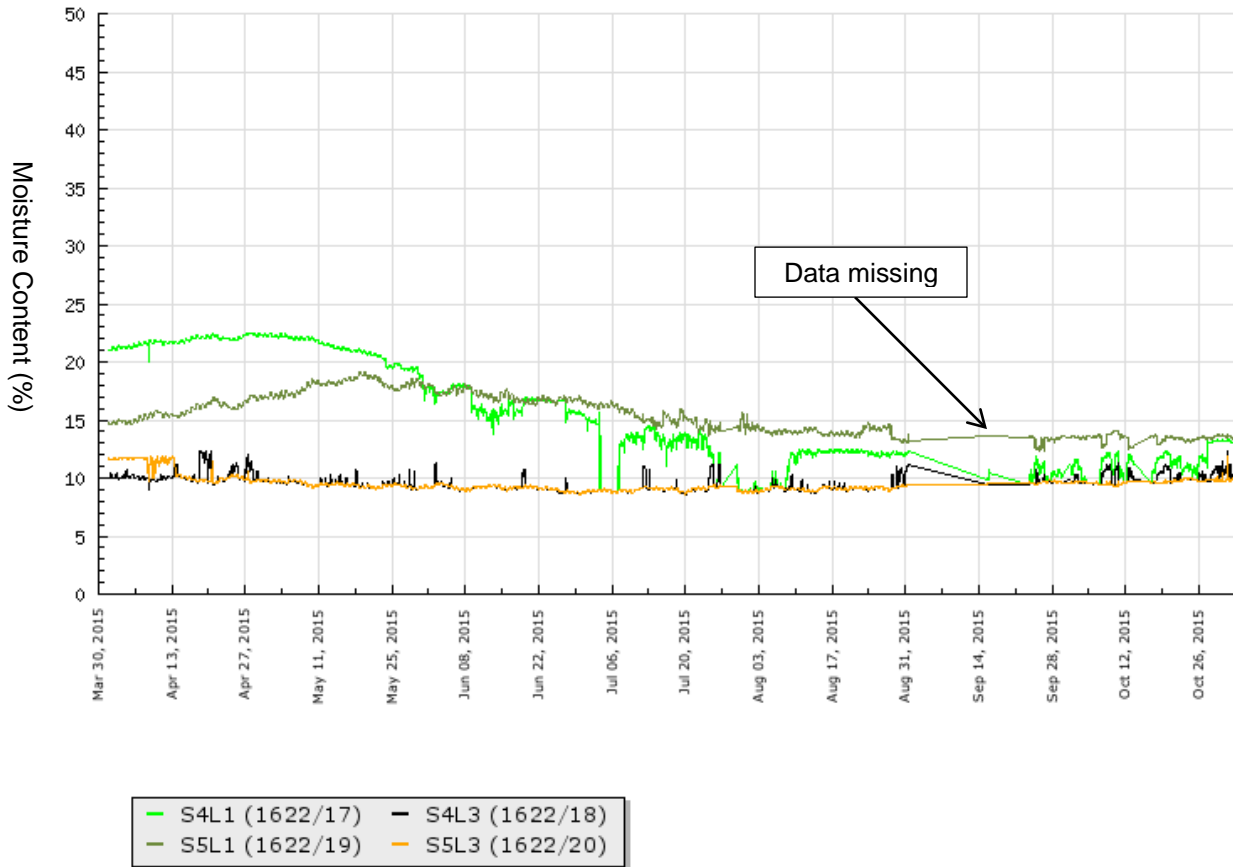
**Figure 21 Moisture content readings from sensors installed in S4 and S5 beams**

Note: L—boards of NLT; number after “L”: 1—top surface; 3—central

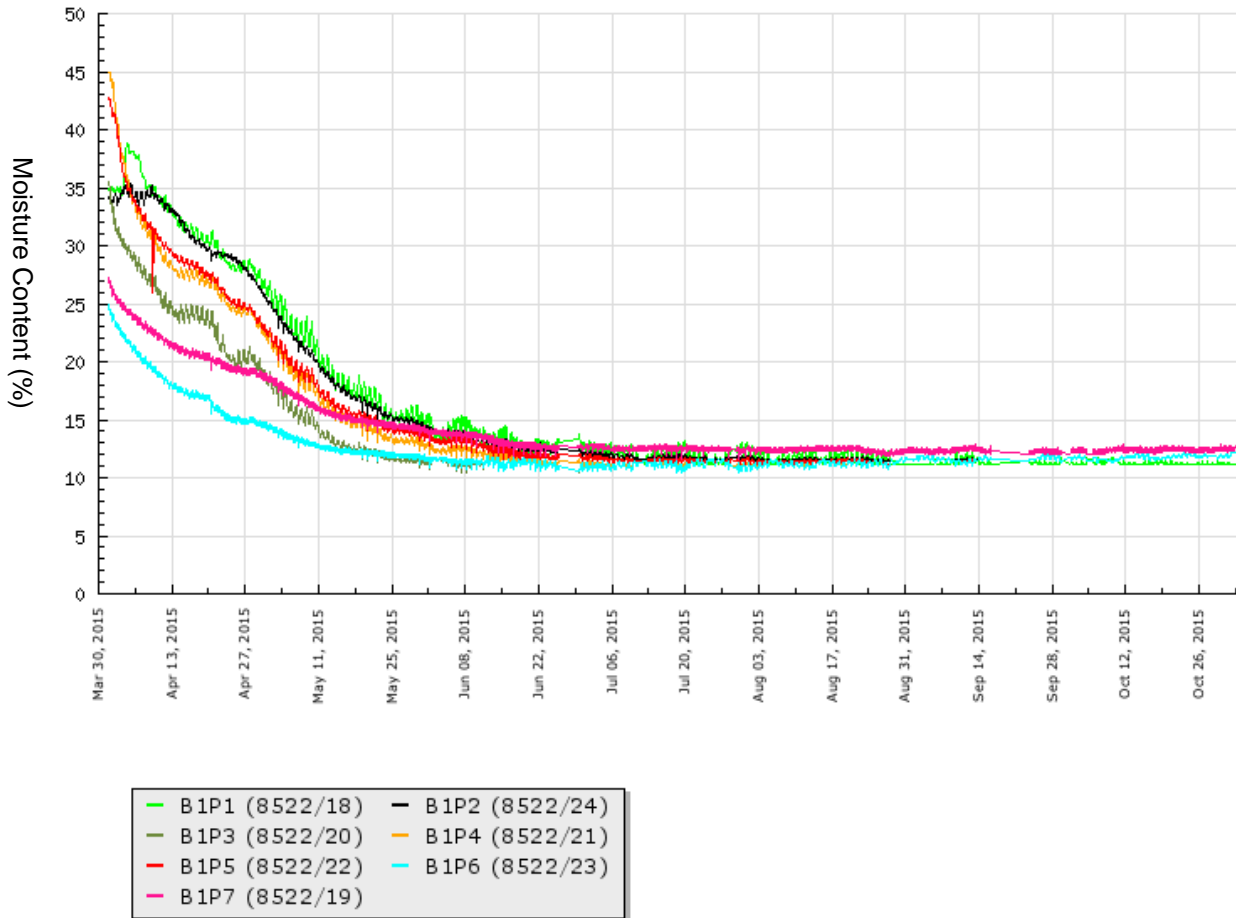
**Figure 22 Moisture content readings from sensors installed in plywood sheathing of assembly B1**

Note: P—plywood; number after “P”: 1, 2—top layer; 3, 4, 5—middle layer; 6, 7—bottom layer of plywood
