# Wetting and Drying Performance and On-site Moisture Protection of Nail-Laminated Timber Assemblies

June 2016

Jieying Wang, Senior Scientist, Advanced Building Systems

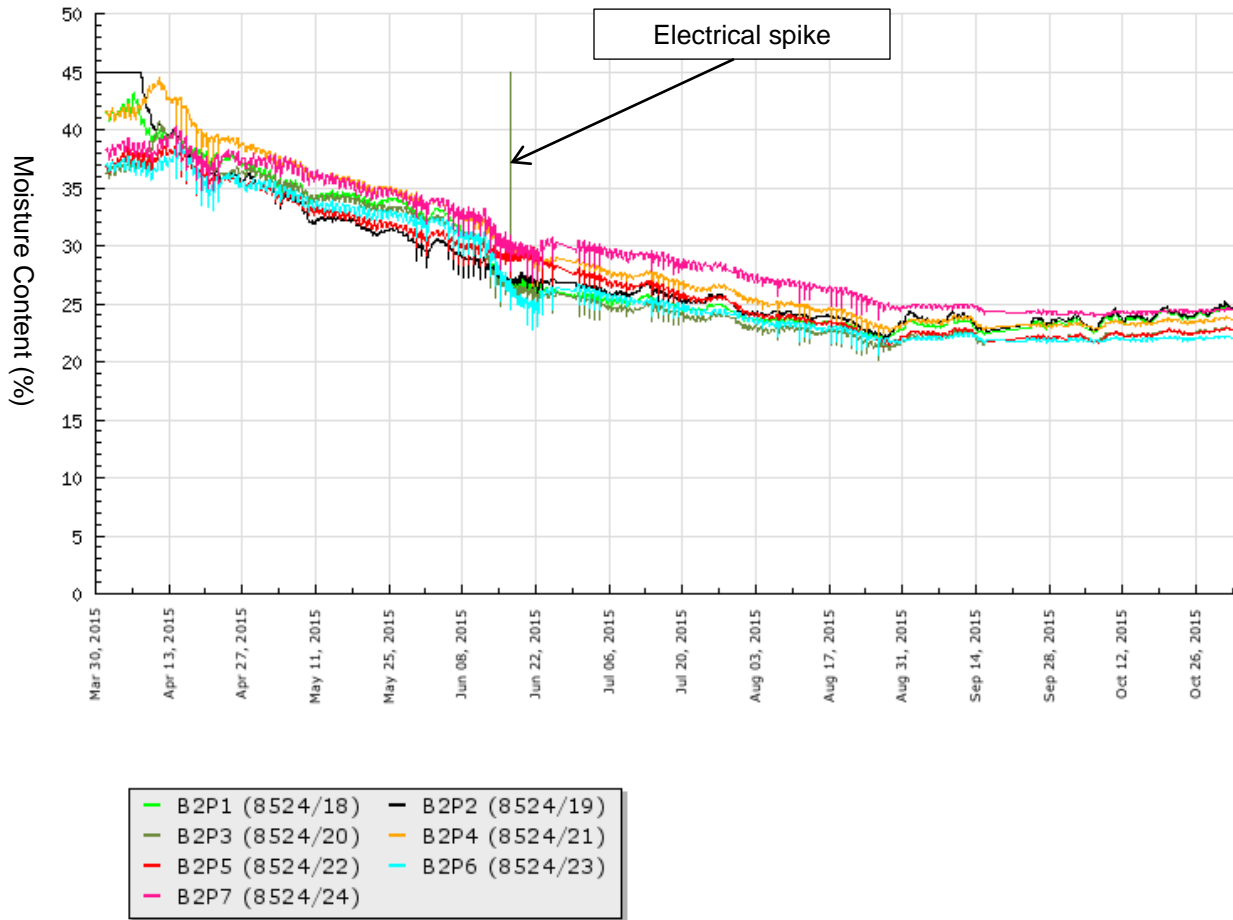
**Figure 23 Moisture content readings from sensors installed in plywood sheathing of assembly B2 (no heating or membrane)**

Note: P—plywood; number after “P”: 1, 2—top layer; 3, 4, 5—middle layer; 6, 7—bottom layer of plywood

When a wetted test assembly which included both NLT beam and plywood with no membrane on the top was supported above a plywood box without heating (i.e., assembly B2, Figure 23–Figure 24), both plywood and NLT beam dried slowly. The plywood reached a MC of 25% at the end of August and actually stayed at MCs above 20% throughout the entire test period of seven months. Even the top surface, which was exposed to the ambient environment in the shed, dried slowly due to the large amount of moisture it absorbed during the wetting procedure and the small drying forces available. Drying of the plywood could also have been retarded by the wet NLT beam below. Most measuring locations in the NLT beam stayed above a MC of 20%, except the bottom surface, with the MC reduced below 20% in about two months. When the same assembly was supported on a plywood box with heating provided inside (i.e., B3) (Figure 25–Figure 26), the drying of both plywood and NLT beam appeared to slightly speed up, particularly the plywood over the summer (Figure 25). The MCs in plywood reduced to around 20% after about two months. But the central areas of NLT did not drop to 20% until the end of August, after about five months into the drying test.

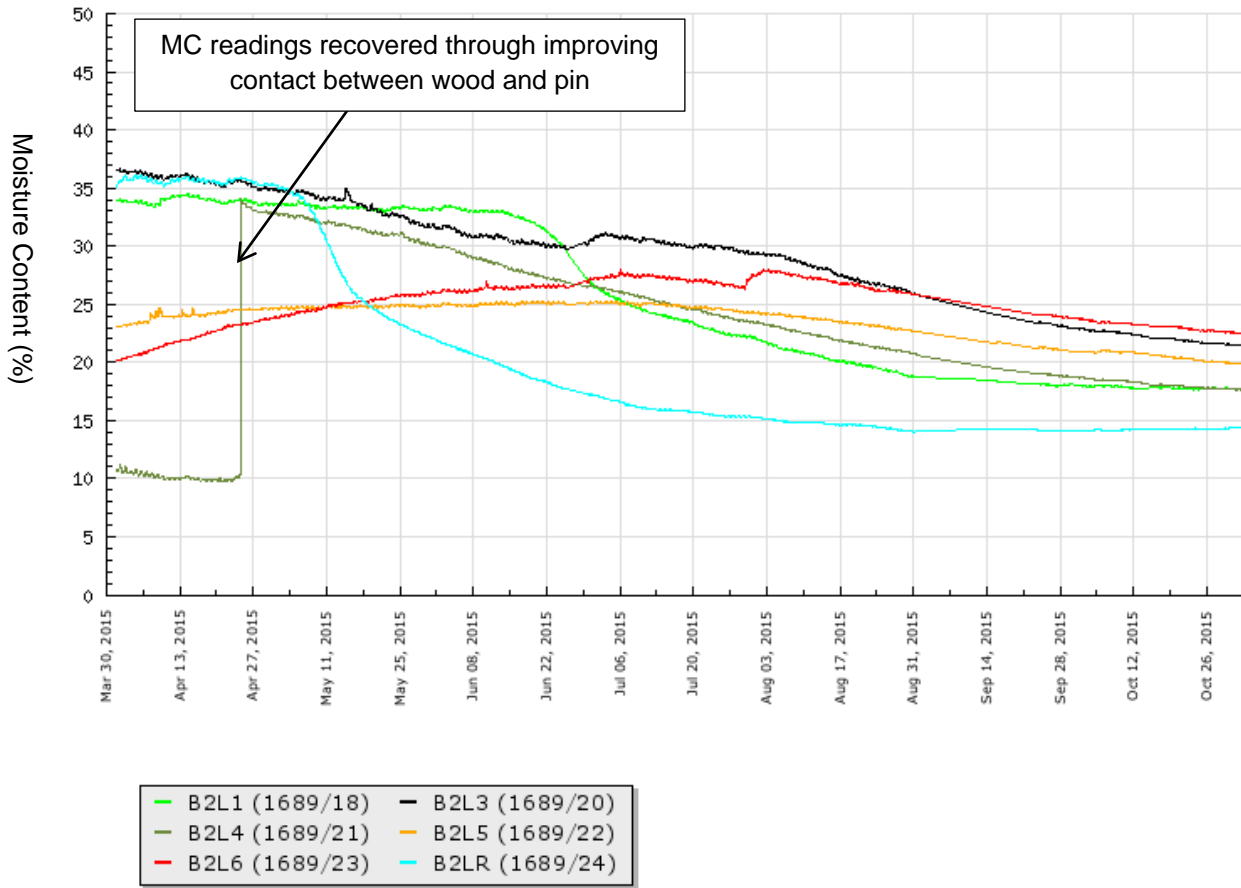
**Figure 24 Moisture content readings from sensors installed in beam of assembly B2 (no heating or membrane)**

Note: L—boards of NLT; number after “L”: 1—top surface; 3, 4, 5, 6—central; R—bottom

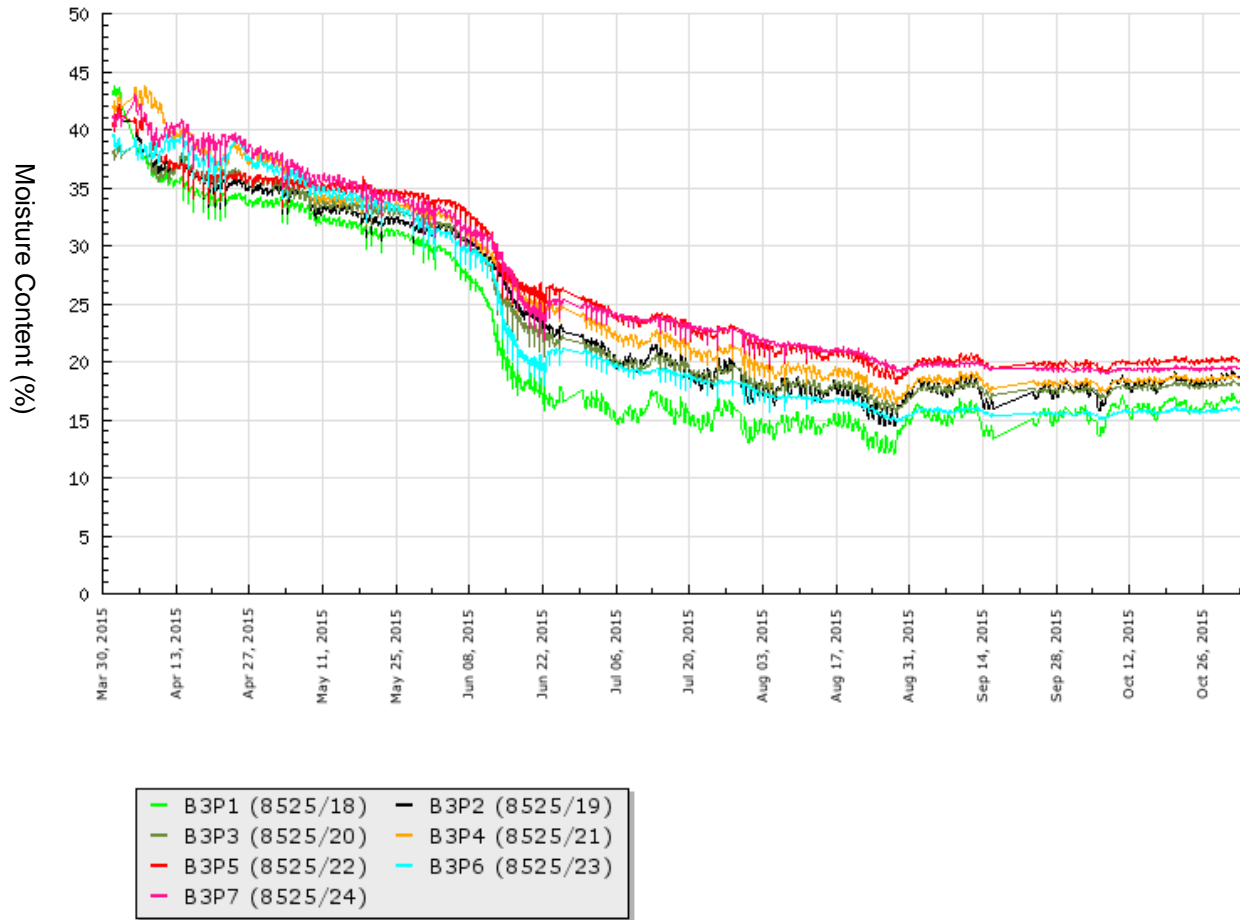
**Figure 25 Moisture content readings from sensors installed in plywood sheathing of assembly B3 (no membrane, with heating)**

Note: P—plywood; number after “P”: 1, 2—top layer; 3, 4, 5—middle layer; 6, 7—bottom layer of plywood

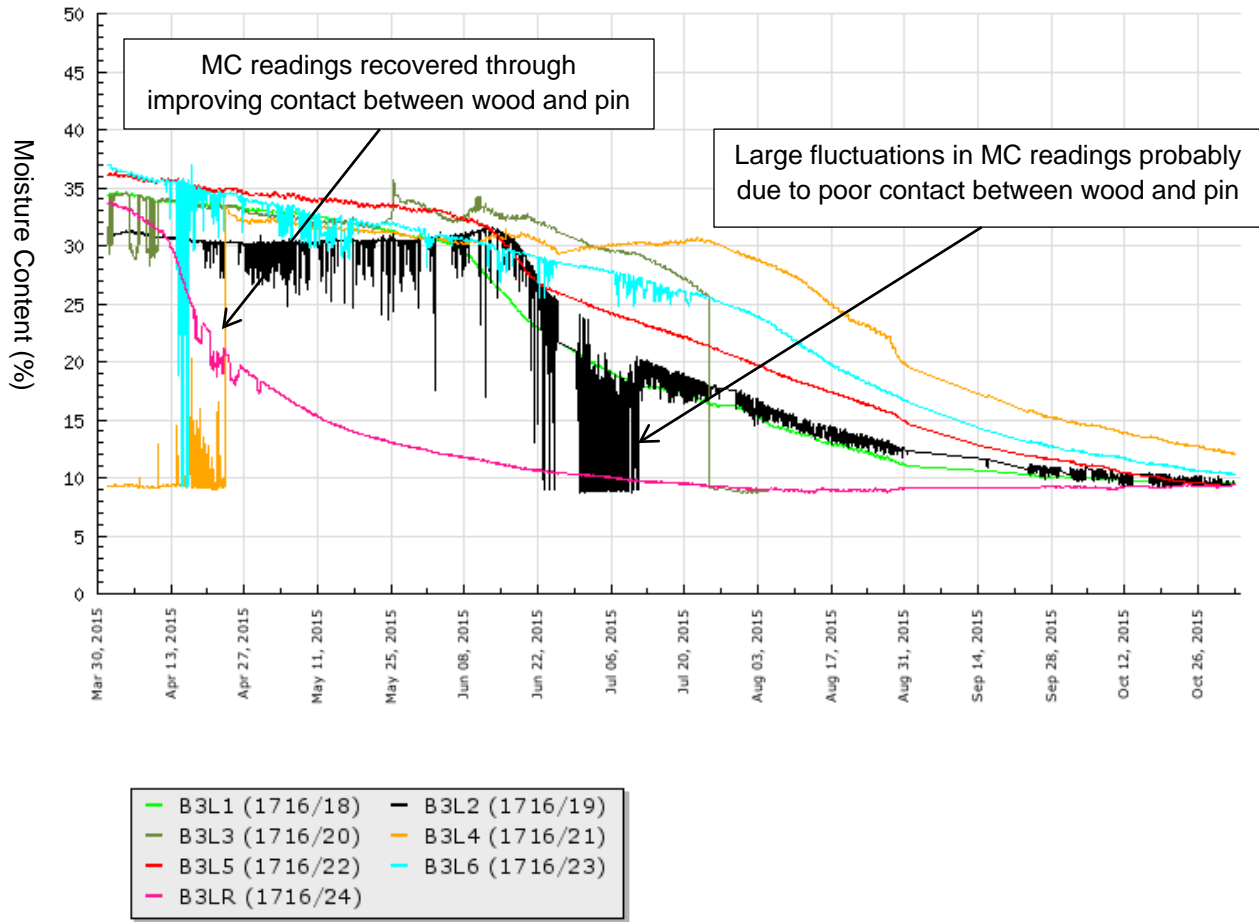
**Figure 26 Moisture content readings from sensors installed in beam of assembly B3 (no membrane, with heating)**

Note: L—boards of NLT; number after “L”: 1, 2—top surface; 3, 4, 5, 6—central; R—bottom

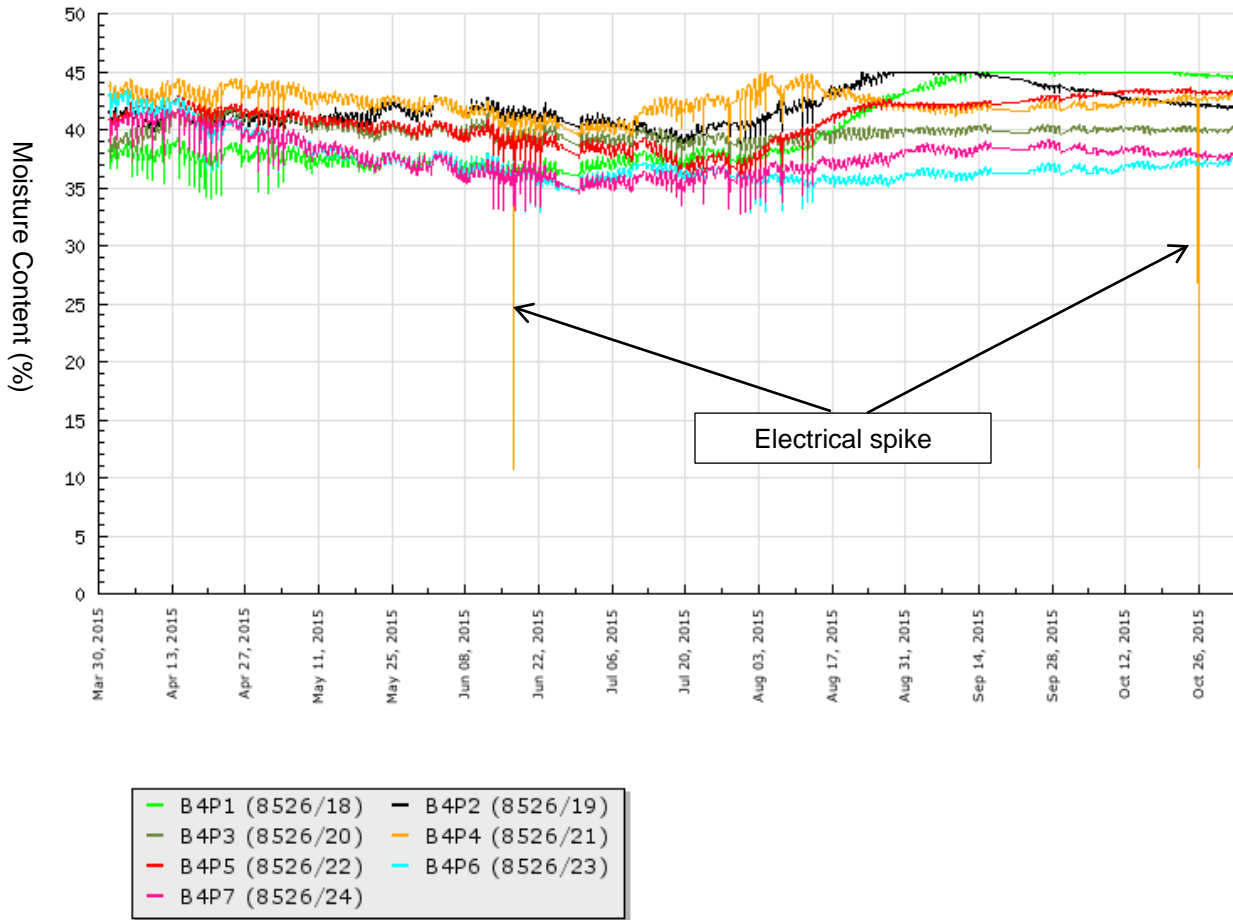
**Figure 27 Moisture content readings from sensors installed in plywood sheathing of assembly B4 (no heating, with membrane)**

Note: P—plywood; number after “P”: 1, 2—top layer; 3, 4, 5—middle layer; 6, 7—bottom layer of plywood

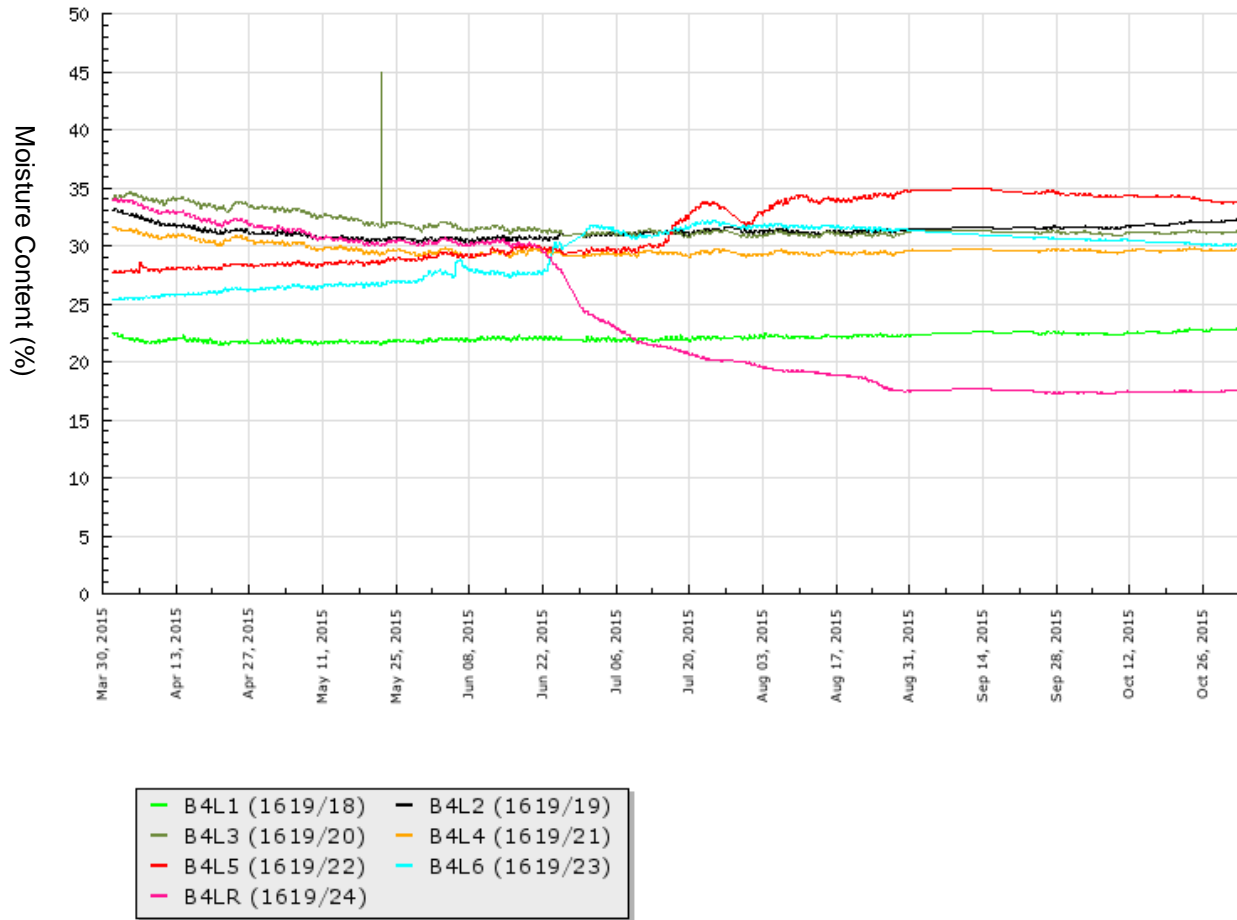
**Figure 28** Moisture content readings from sensors installed in beam of assembly B4 (no heating, with membrane)

Note: L—boards of NLT; number after “L”: 1, 2—top surface; 3, 4, 5, 6—central; R—bottom

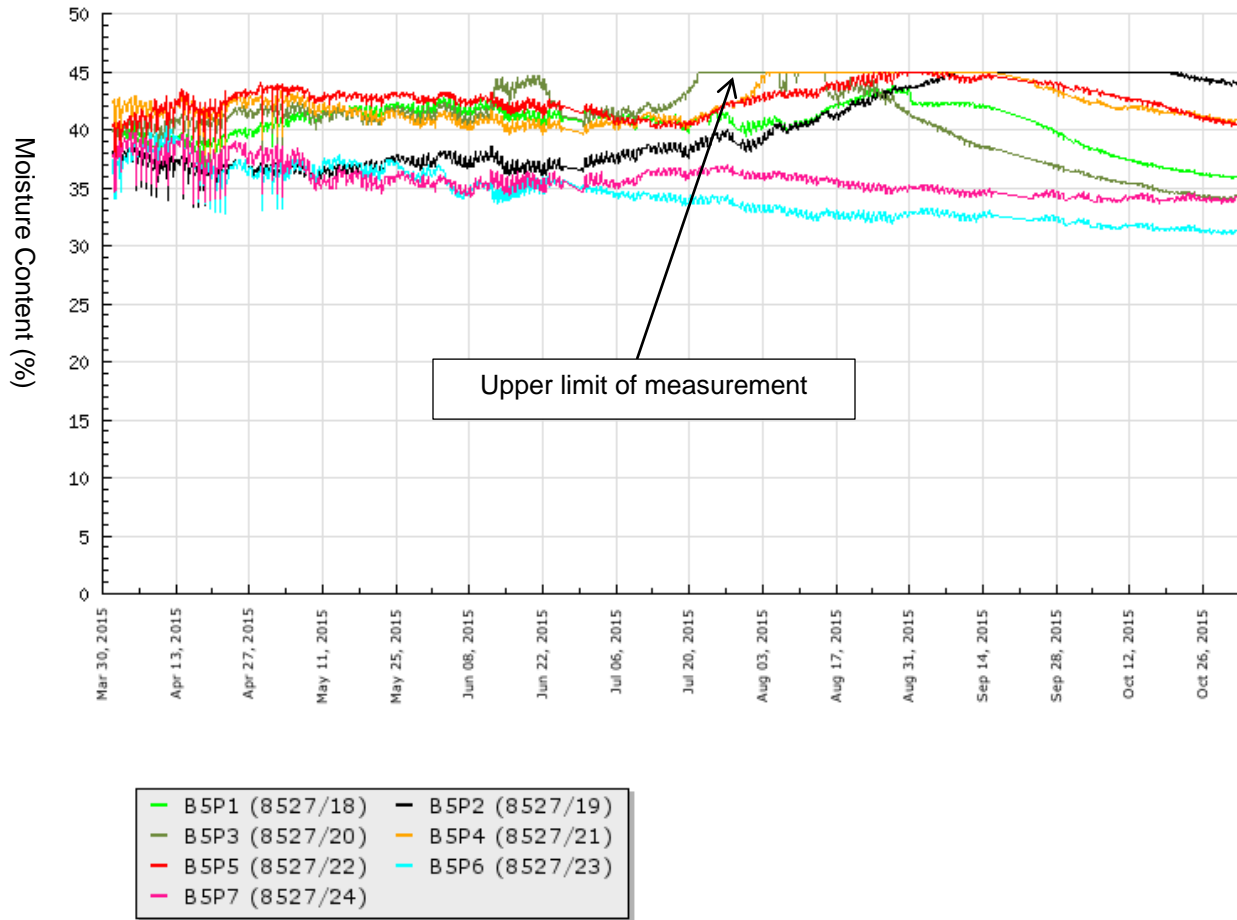
**Figure 29 Moisture content readings from sensors installed in plywood sheathing of assembly B5 (with both heating and membrane)**

Note: P—plywood; number after “P”: 1, 2—top layer; 3, 4, 5—middle layer; 6, 7—bottom layer of plywood

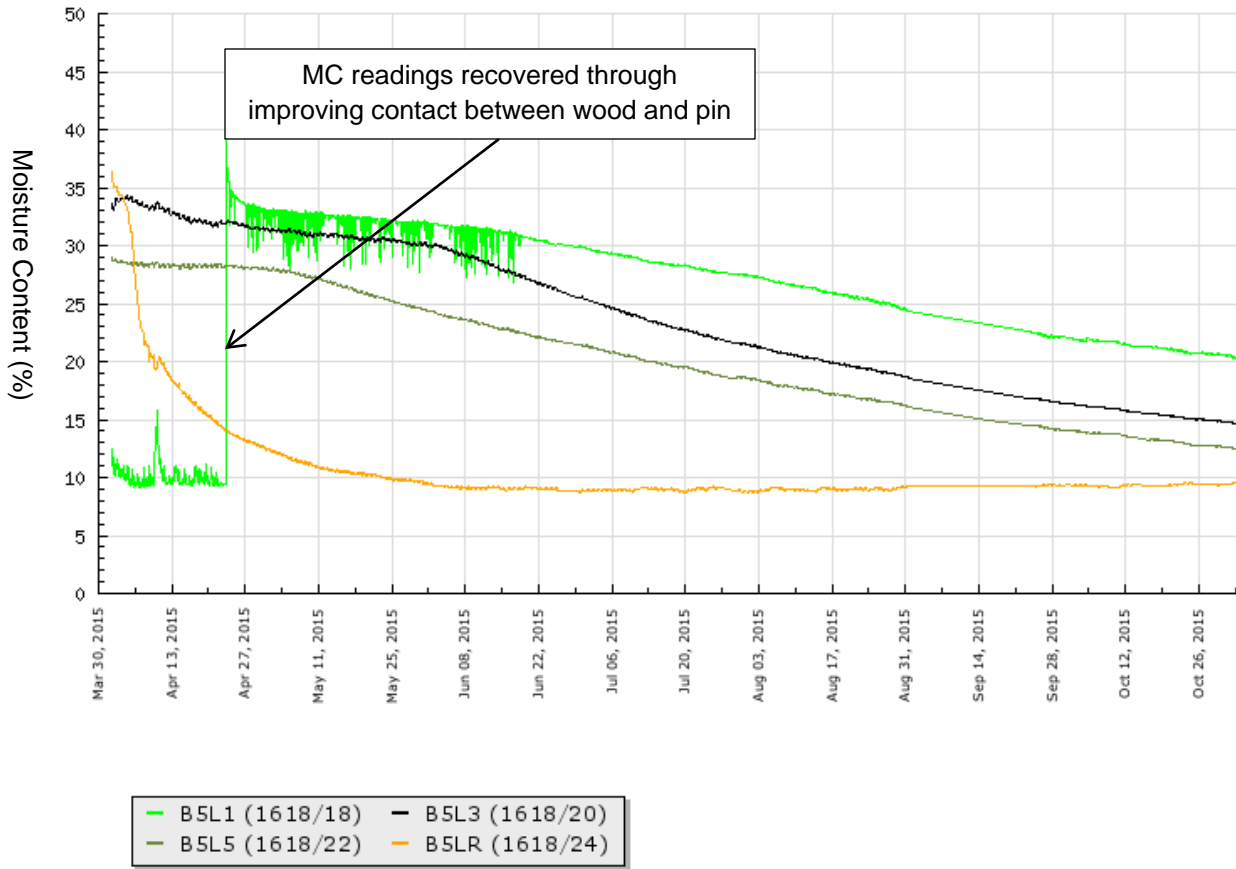
**Figure 30 Moisture content readings from sensors installed in beam of assembly B5 (with both heating and membrane)**

Note: L—boards of NLT; number after “L”: 1—top surface; 3, 5—central; R—bottom

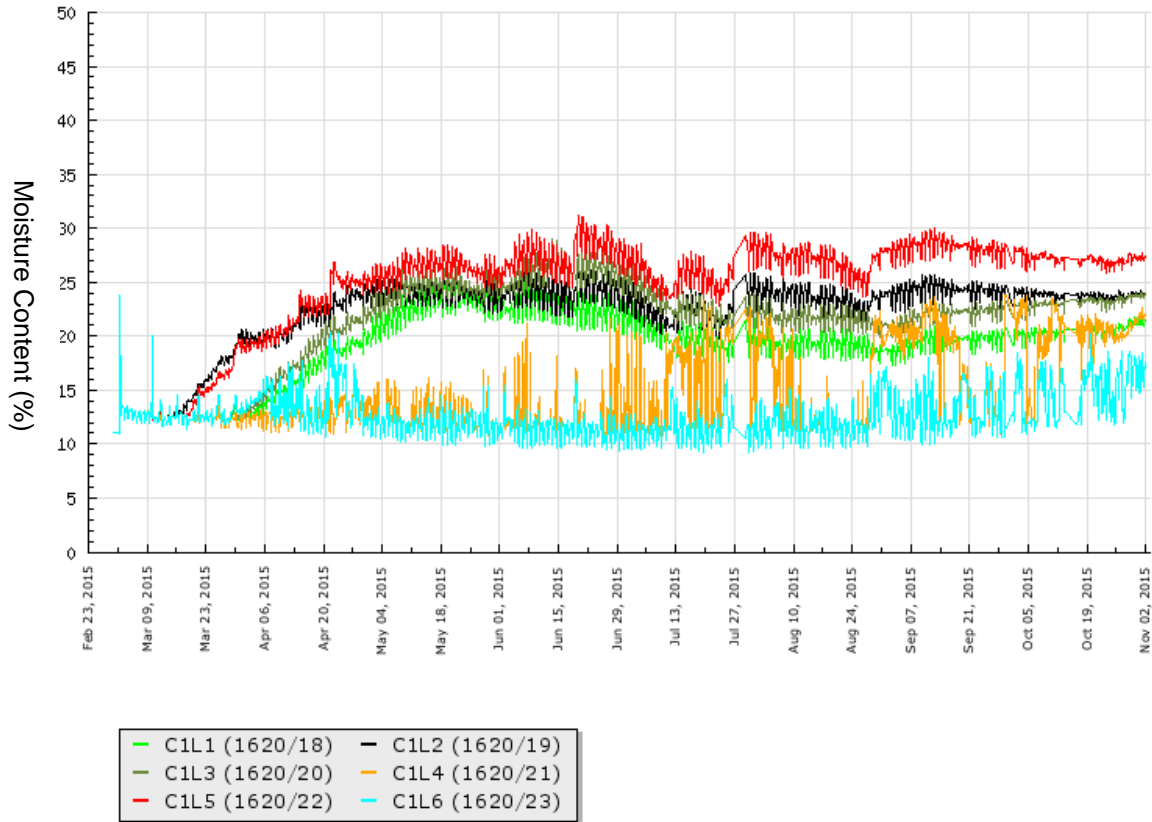
**Figure 31 Moisture content readings from sensors installed in cross-laminated timber during outdoor exposure**

Note: Number after “L”: 1, 2—central top surface board; 3, 4, 5—central board of the middle layer, with C1L3 and C1L5 close to the two edges of the board; 6—centre of the bottom surface board

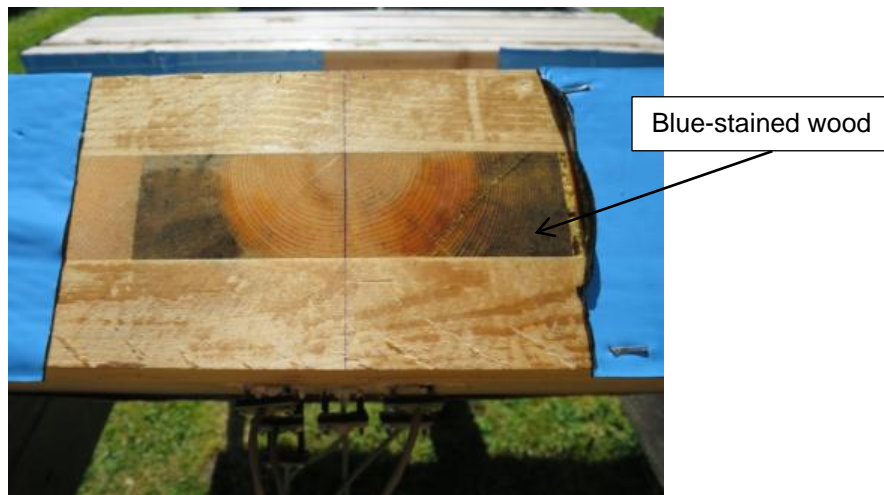
**Figure 32 Picture showing central board of the middle layer, with dark colour of blue-stained sapwood indicating elevated moisture content**

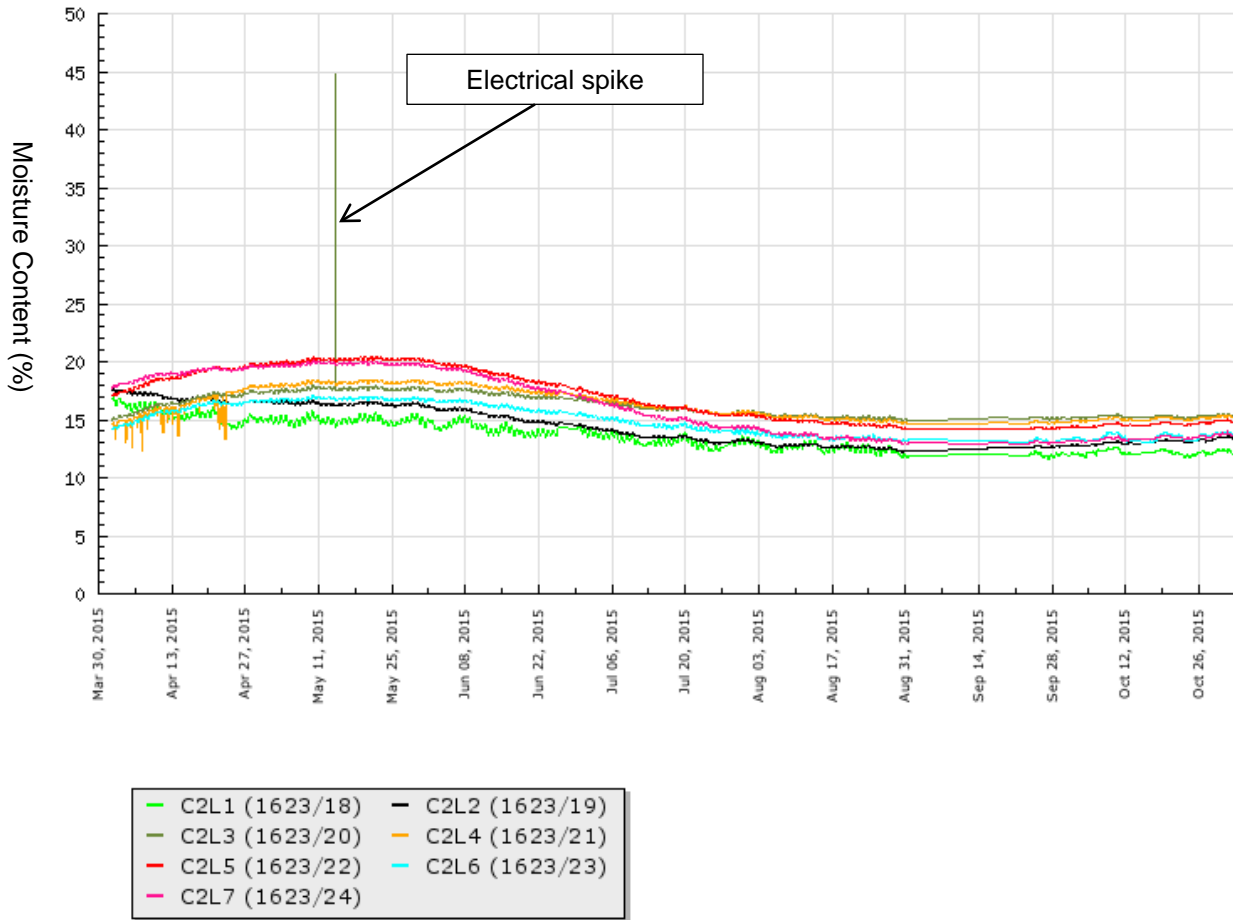
**Figure 33 Moisture content readings from sensors installed in cross-laminated timber drying in shed following laboratory wetting**

Note: Number after “L”: 1, 2—central top surface board; 3, 4, 5—central board of the middle layer, with C2L3 and C2L5 close to the two edges of the board; 6, 7—central bottom surface board

By comparison, the laboratory assessment presented a slightly different picture for the wetting and drying behaviour of CLT (Figure 33). It was found that the MC at any measuring location was below 20% after the intense wetting procedure in the laboratory. During the drying test under the sheltered conditions in the shed, the MC readings did not reduce considerably. These two CLT specimens indicated that the time of exposure, i.e., wetting time, was a key condition for the core of a CLT panel to gain MC; however, the drying was very slow once moisture penetrated deep in the panel. The MC at the surface of each board in a CLT panel would be anticipated to be higher than that measured in the centre. This was not measured, but we noticed that decay was identified in the end grain of boards in the reference CLT specimen, which was left to dry in the shed following the laboratory wetting procedure (Figure 34). Note such decay initiation is not specific to the material itself but had mostly resulted from the conditions of the test. The impermeable membrane used for edge sealing must have stopped moisture evaporation from the wet end grain and have created favourable conditions for decay to initiate and progress over a period of 8 months under the relatively warm conditions. This confirms the importance of maintaining a good drying ability for wood assemblies to ensure long-term durability. Installing an impermeable membrane or other low-permeance materials on wood, mass timber members in particular, needs to be carefully considered (or reconsidered) due to the negative impact it has on the drying ability. This has been emphasized in many best practice guides, such as the CLT Handbooks (Gagnon and Pirvu 2011; Karacabeyli and Douglas 2013).

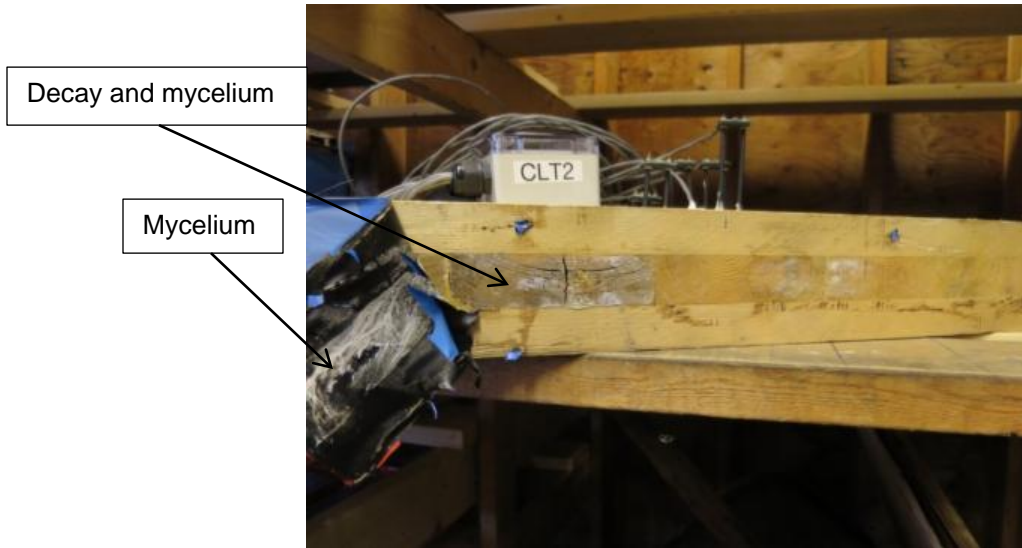
**Figure 34** Decay started from end grain with mycelium visible on impermeable membrane after eight months in shed following a laboratory severe wetting procedure

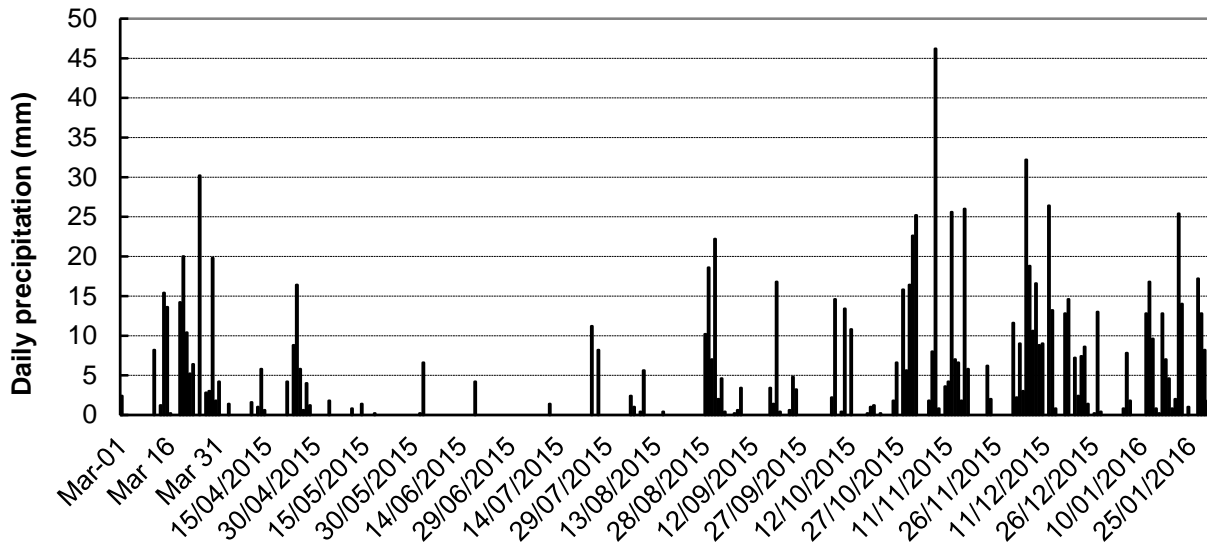
App-Figure 1 Daily precipitation during outdoor exposure from March to November, 2015<sup>3</sup>

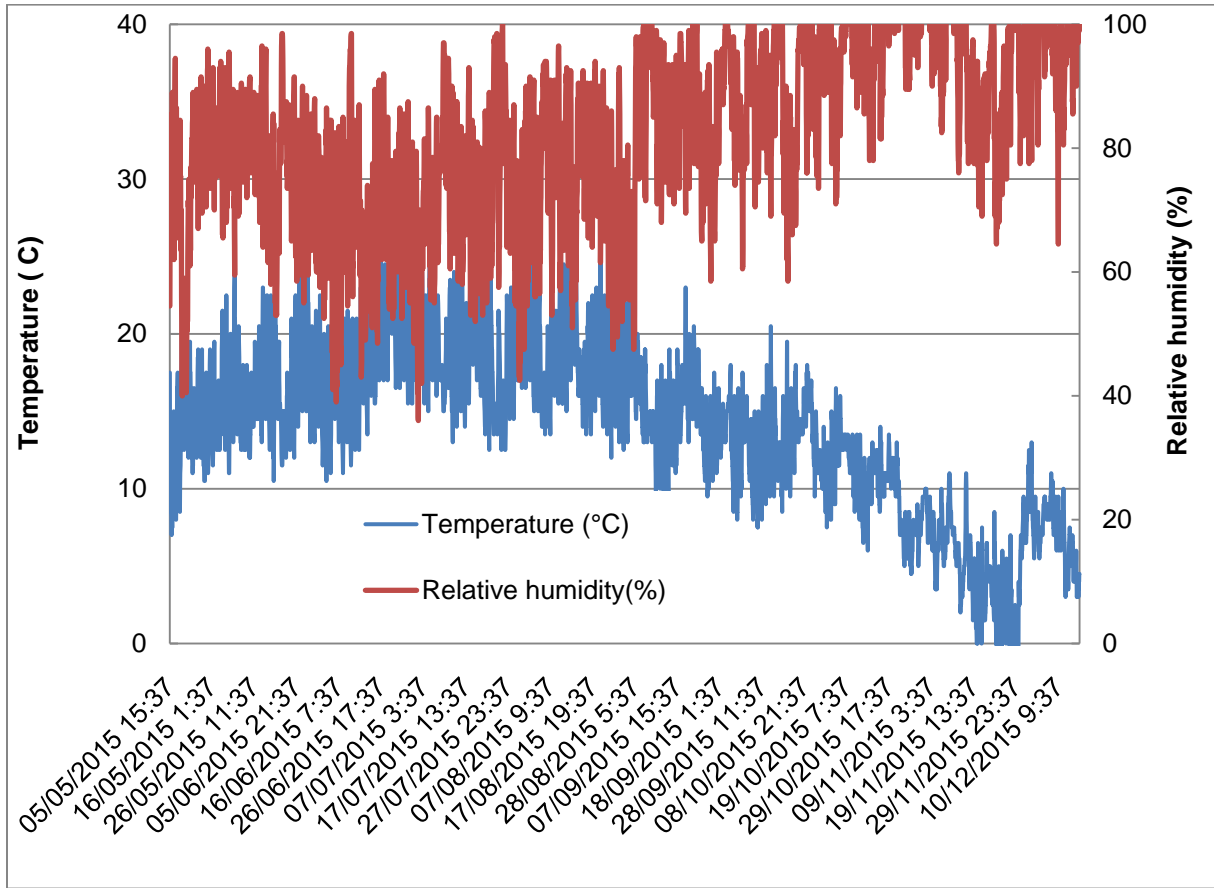
**App-Figure 2** Relative humidity and temperature recorded by HOBO under sheltered exterior conditions

Test assemblies from Group 1 were placed on shelves exposed to exterior conditions, starting at the end of February, 2015 (Figure 3; see Section 4.4 for description about the additional field exposure test). See App-Figure 1 and App-Table 1 (Appendix II) for information on the number of days of rain and precipitation amounts. Rainfall mostly occurred in the spring, fall and winter with a total precipitation of about 1037 mm from March 2015 to January 2016. The summer turned out to be drier than normal, with little or no rain from May to August. An RH/T sensor (HOBO, EL-USB-2-LCD RH/TEMP data logger) was used to measure the ambient temperature and relative humidity (RH) under a test assembly, with the RH and temperature readings shown in App-Figure 2 (Appendix II). There

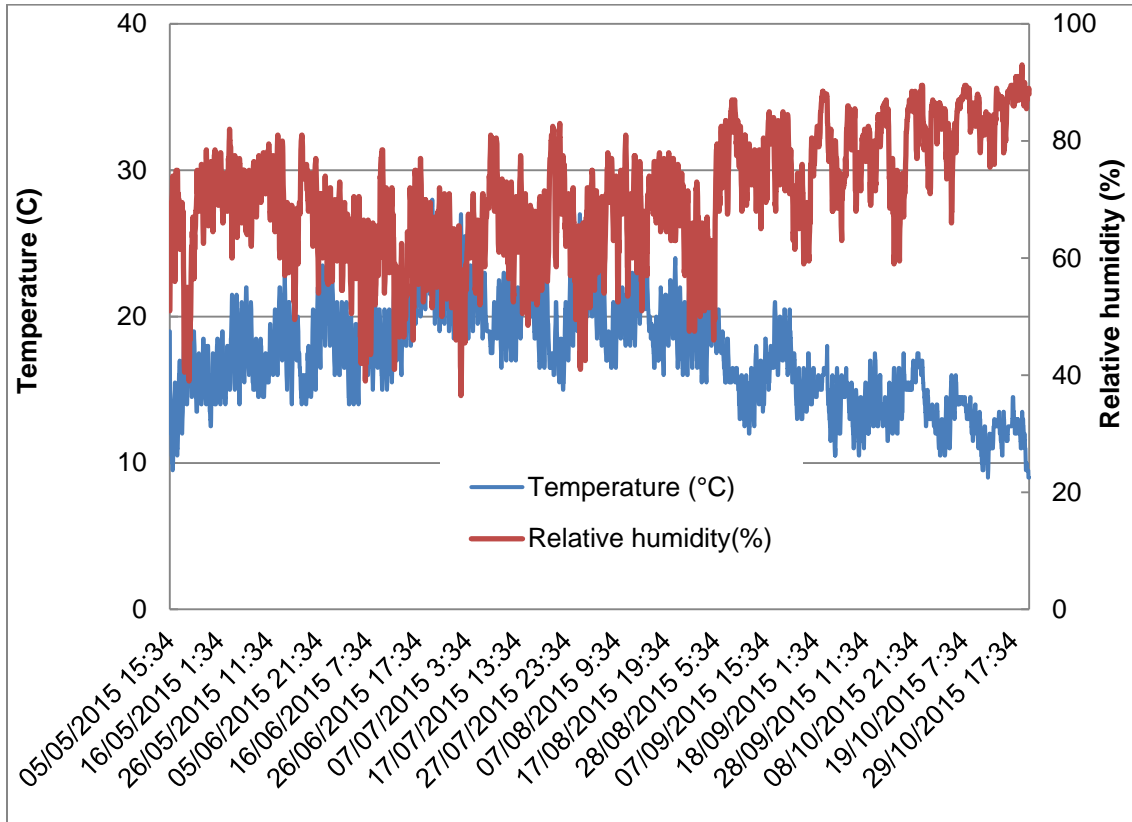
**App-Figure 3** Relative humidity and temperature recorded by HOBO in the shed

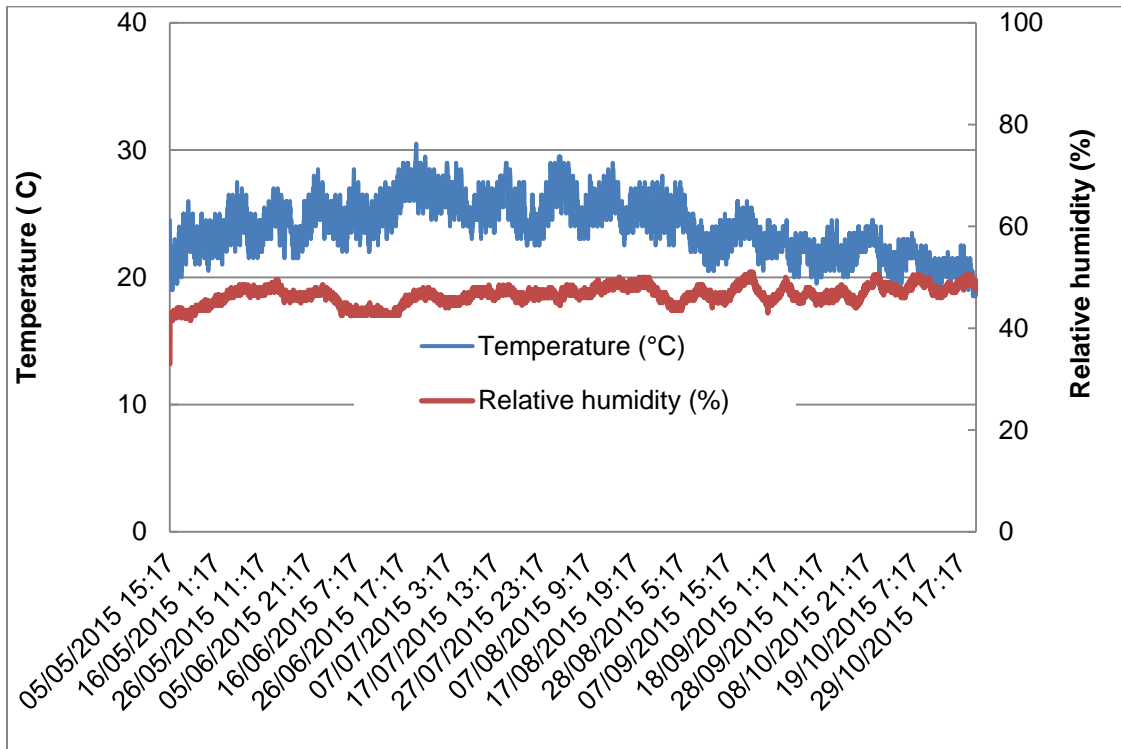
App-Figure 4 Relative humidity and temperature recorded by HOBO in the B1 box
