MASS TIMBER AND INSURANCE - Q&A

CAN MASS TIMBER MEET 2HR or 3HR FIRE TEST REQUIREMENTS?

CAN MASS TIMBER BE REPAIRED AFTER A FIRE OR FLOOD EVENT?

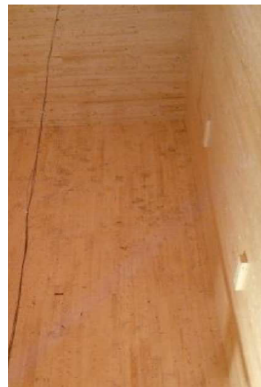
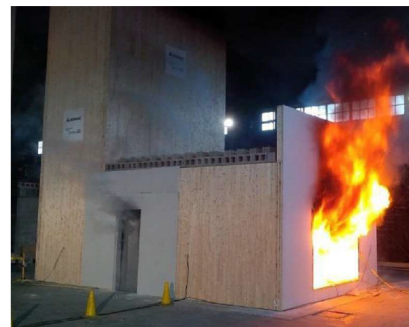
Fire Shaft 2hr Test: No sign of smoke or heat penetration into the shaft.

In association with a 13-story mass timber demonstration project, the Quebec provincial government funded full-scale CLT fire tests to prove CLT’s equivalence to 2-hour-rated noncombustible construction. Tests included a three-story encapsulated CLT apartment simulation that ran for 3 hours. One of the tests focused on a 25-foot CLT stair/ elevator shaft (exposed on the inside face with two layers of gypsum protection on the fire side)². The test ran for 2 hours, and evaluated smoke propagation and leakage as well as shaft structural stability - requirements for a fire exit. At the conclusion of the 2hr test, the report indicated there was no sign of smoke or heat penetration into the shaft.

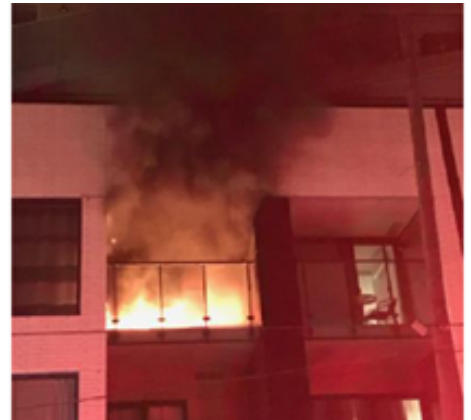
After the fire, the residual water was cleaned up and any affected gypsum board within the compartment was removed. Flooring in the affected area was also removed.

Inspectors cut a section of the concrete topping to assess whether any water had reached the mass timber substrate. It was determined that water did not penetrate the concrete slab and the mass timber was not affected. The prompt removal of water following the fire, and the presence of a concrete topping prevented water from reaching the mass timber beneath.

Remediation may not be required after a fire event: one such case occurred in October 2018, when a fire broke out on a third storey balcony at one of the Arbora buildings in Montreal, QC.⁴ The building is an 8-storey mass timber building above a 1-storey concrete podium. The fire was confined to the balcony, but there was damage to the interior after a window broke. Interior damage from the fire was limited, but water did enter the structure through the window. The structure and fire safety features were effective at preventing further fire spread.
