# **SOLUTIONS FOR UPPER MID-RISE AND HIGH-RISE MASS TIMBER CONSTRUCTION**

*REHABILITATION OF MASS TIMBER FOLLOWING  
FIRE AND SPRINKLER ACTIVATION*

April 30, 2019

Client: Natural Resources Canada

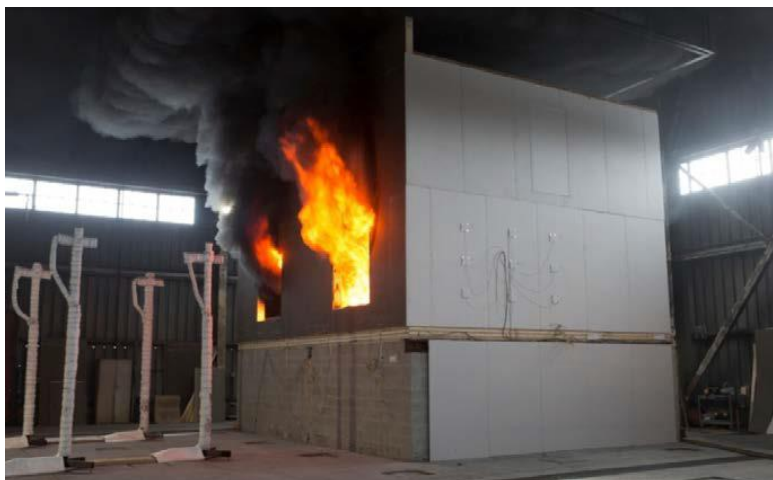
Figure 2. NRC mid-rise consortium CLT apartment fire test [10]

In the mid-rise CLT test conducted by NRC [10], a fire burned in a fully furnished apartment unit where all CLT surfaces were protected with 2 layers of 12.7 mm (½ in) Type X gypsum board. The test was terminated after 185 min. Charring occurred on the interior face of CLT panels within the compartment, but the depth of charring was not measured. In these tests flames projected out the window, as shown in Figure 2, but the exterior side of the CLT panels did not char (except at the lintel) on the exterior side which was protected with an outboard insulation system. In some areas, such as a load-bearing wall (WA3), temperatures behind the gypsum board reached a maximum of 550°C and stayed at that temperature until the end of the test. This indicates that flaming combustion did not occur in this location, although the wood had charred. At the floor panel, which was protected by hardwood flooring, the CLT surface ply started to char but again there was no flaming combustion. At the ceiling, in the bedroom (where the fire initiated on the bed) temperatures behind the gypsum again stayed below 500°C (except at the centre of the ceiling). There was minimal or no flaming combustion of the ceiling panels in the bedroom. In the living room the gypsum board mostly stayed in place until the end of the test. Peak temperatures exceeded 600°C along the centreline of the living room, indicating flaming combustion had occurred.

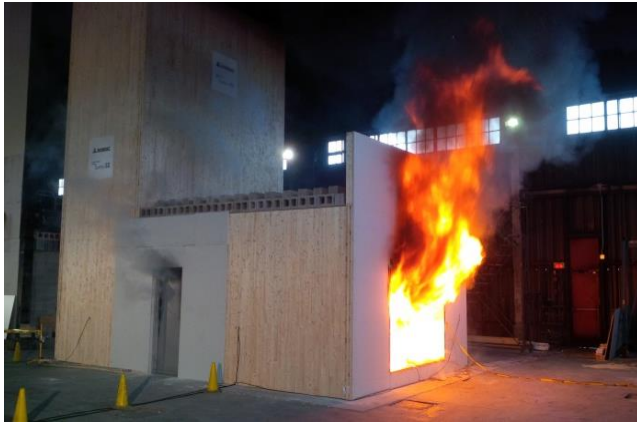
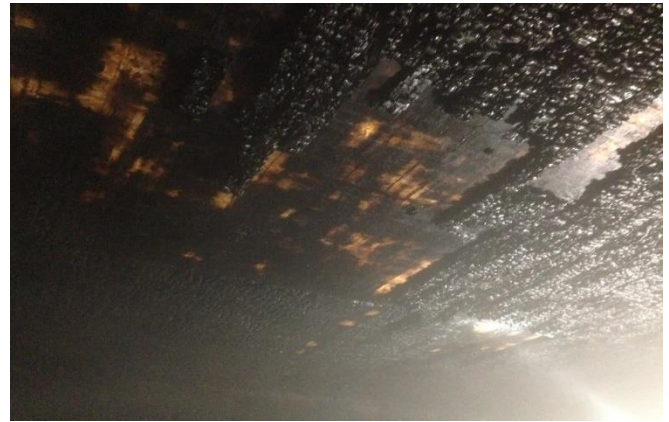
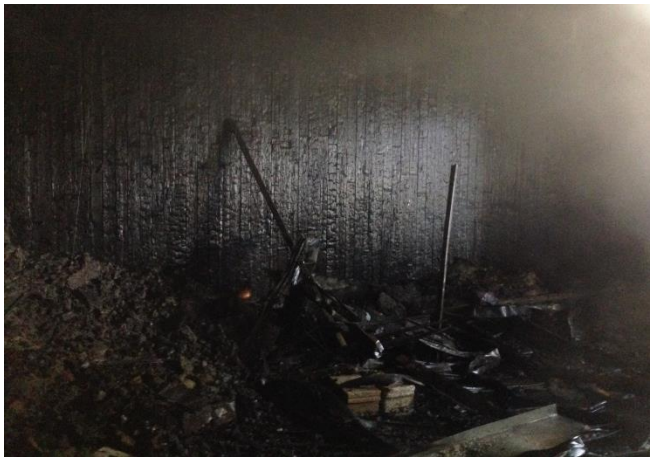
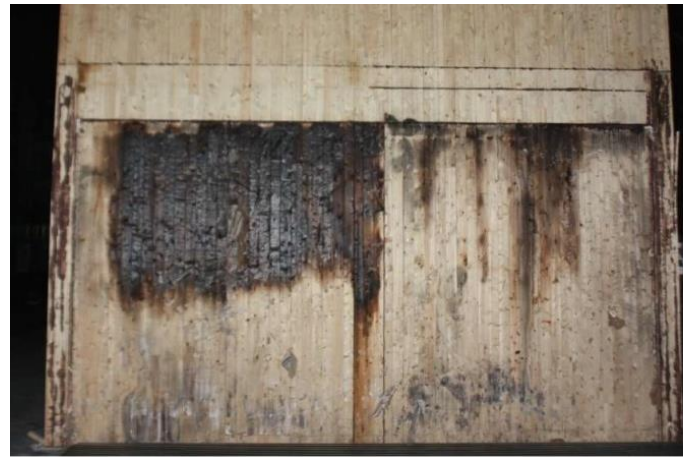
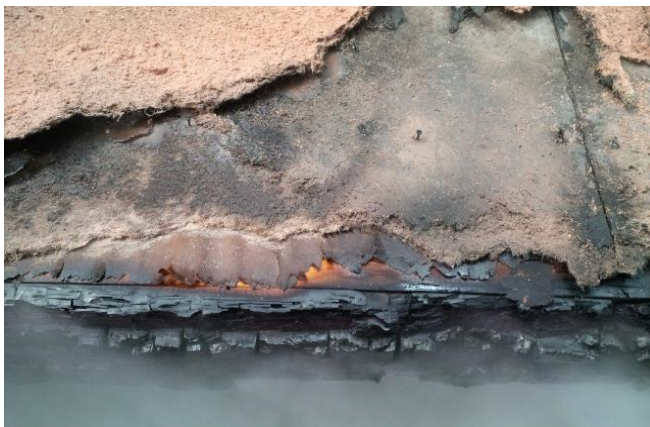
Figure 3. Origine mass timber demonstration fire

a) Compartment fire

b) Charring of ceiling. Some 2nd CLT layer in place, 3rd layer exposed

c) Charring of side wall

d) Condition of shared wall after test (NRC)

e) Charring at window opening, evidence of uncharred wood beneath gypsum

f) Water leakage into shaft during extinguishment

In 2014 a demonstration fire was conducted to confirm the performance of a mass timber compartment adjacent to a shaft for use in the 13-storey Origine building [17]. Images from the demonstration are shown in Figure 3. The 5-ply CLT compartment walls were protected with two layers of 15.9 mm (5/8 in) Type X gypsum board; the ceiling was protected with one layer. The shared shaft wall had an additional cold-formed steel stud wall filled with rock fibre insulation for acoustic purposes. The fire lasted for two hours before being extinguished with fire hoses. During the test the gypsum board on the ceiling fell and the first CLT ply of the ceiling was observed to fall off (the CLT conformed to the 2012 edition of ANSI/PRG 320 [18] and not to the latest 2018 edition [19]); after extinguishment sections of the 2<sup>nd</sup> layer were knocked down exposing the third layer which was lightly charred and in some places uncharred (Figure 3 b). The two layers of gypsum board stayed in place on the perimeter walls and temperatures remained below 500°C at the CLT surface, indicating no flaming combustion of the CLT walls. Gypsum board fell was knocked off the walls during hose application. Only the surface ply of the walls had charred (Figure 3 c), the inner plies were unaffected. Only 5 mm of char was noted on the upper left half of the shared wall (Figure 3 d), it was otherwise uncharred. Charring occurred around the window opening, but otherwise the exterior face of the CLT was uncharred. After the fire was extinguished some water leakage was apparent under the shared wall into the shaft (Figure 3 e).

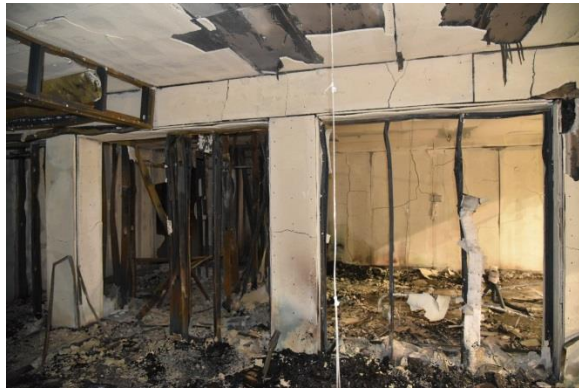
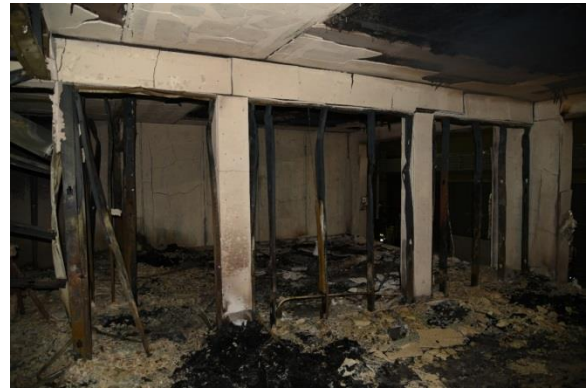
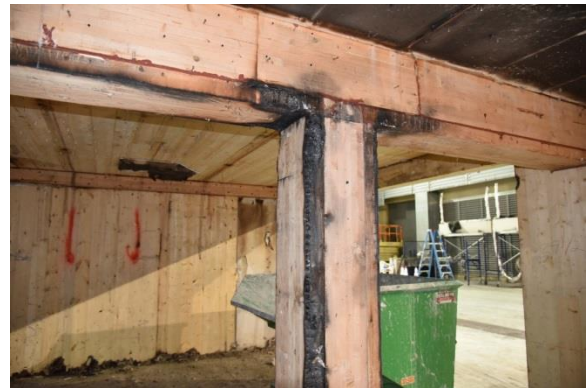
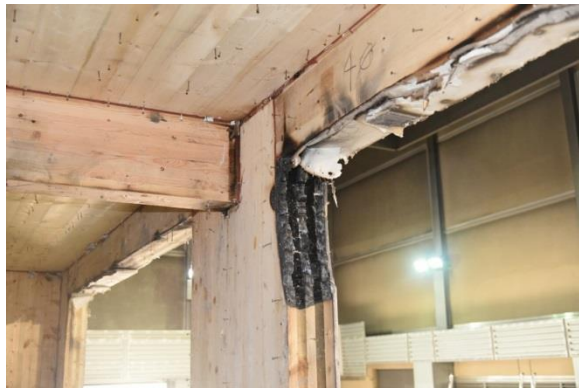
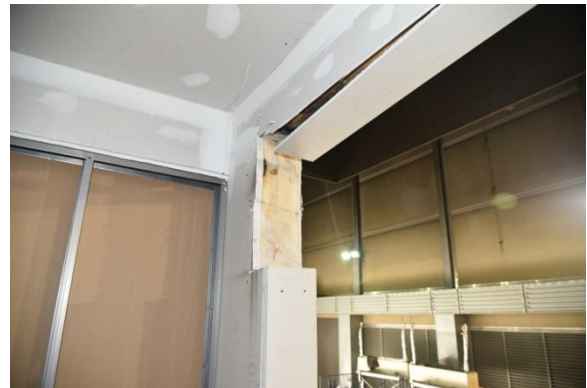
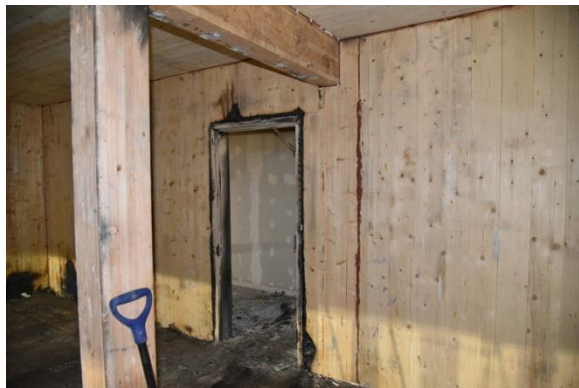
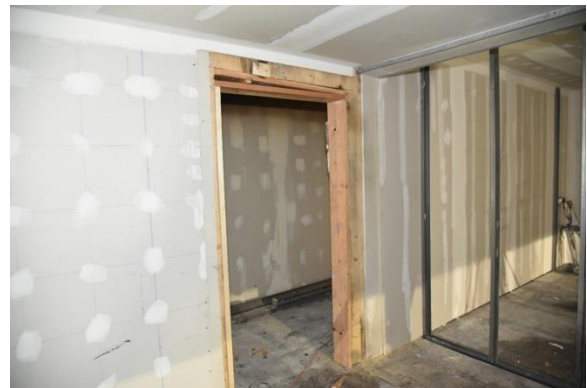
Figure 4. US FPL CLT compartment tests [20]

a) Compartment after Test 1

b) Compartment after Test 2

c) Replacement of ceiling panels

d) Damaged column and beam

e) damage at second floor window

f) charred section removed at window

g) damage around apartment door

h) repaired apartment door frame

A series of five full-scale CLT compartment fire experiments were conducted by the US Forest Products Laboratory (FPL) in 2017 to support changes to the International Building Code to allow tall wood construction [20]. This included an investigation of how compartment fires are affected by exposed CLT surfaces as well as the effectiveness of sprinklers. Fires were initiated in the base of the kitchen cabinets and tests lasted up to four hours. Images from the tests are provided in Figure 4. The main structure was reused when possible. After each test all of the gypsum was removed and replaced (depending on the design of the subsequent test and extent of damage). The interior cold-formed steel stud walls and dropped ceiling were also replaced. After Test 2, which included some sections of exposed wood, the second floor ceiling was replaced. Figure 4c shows the ceiling being replaced and the charring that occurred on the exposed sections. The support columns and mid-span beams sustained fire damage during the test (Figure 4d). Damaged sections were removed and replaced with equivalent wood pieces. Some localized damage occurred near openings. This was repaired by cutting out the damaged section and replacing it with equivalent material (comparison between Figure 4 e and f). Figure 4g and Figure 4h demonstrate damage around a door frame and its repair. The repairs that were done, were sufficient for the structure to be reused for testing, but are not necessarily indicative of appropriate repair after a fire for in a building in-use. After a fire, it is important to remove all charred wood and to appropriately seal wood exposed to fire to prevent any carcinogenic off-gassing in the future. Test 4 included the use of sprinklers, and Test 5 evaluated the performance of a delayed response sprinkler; both of these tests included exposed wood surfaces in the living room and bedroom. In Test 4 the sprinklers were activated at 2 min 37 s and extinguished the fire, no charring occurred in the living room ceiling. In Test 5 the sprinklers activated at 23 min and were also still able to extinguish the fire.

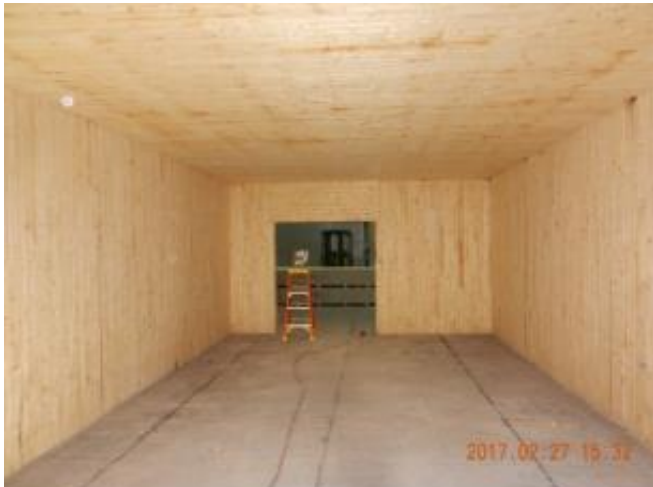
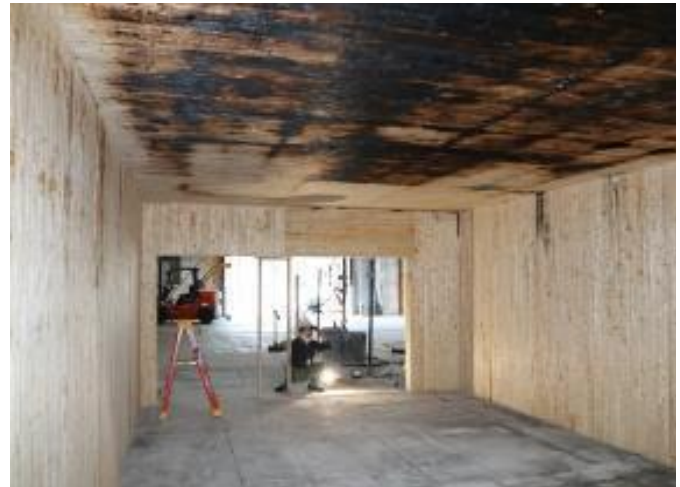
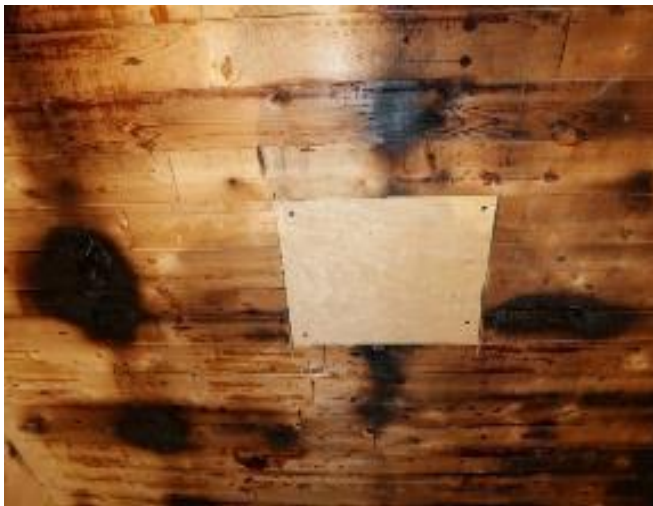
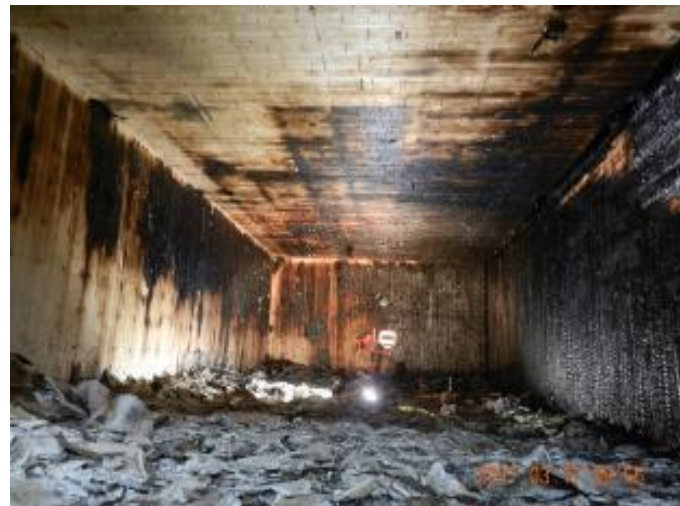
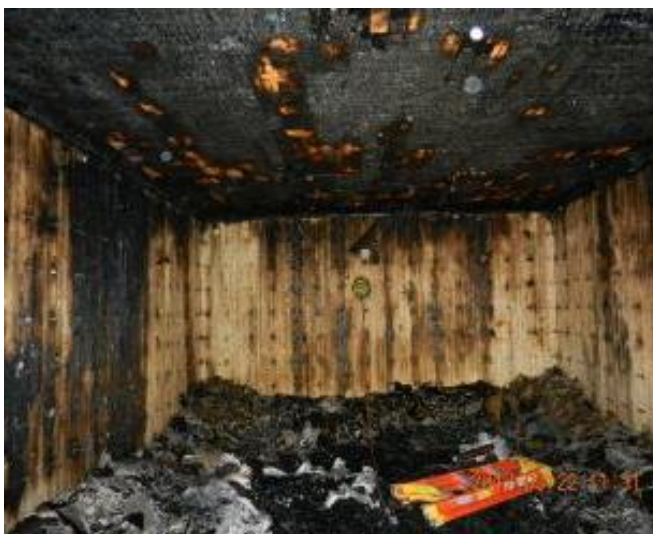
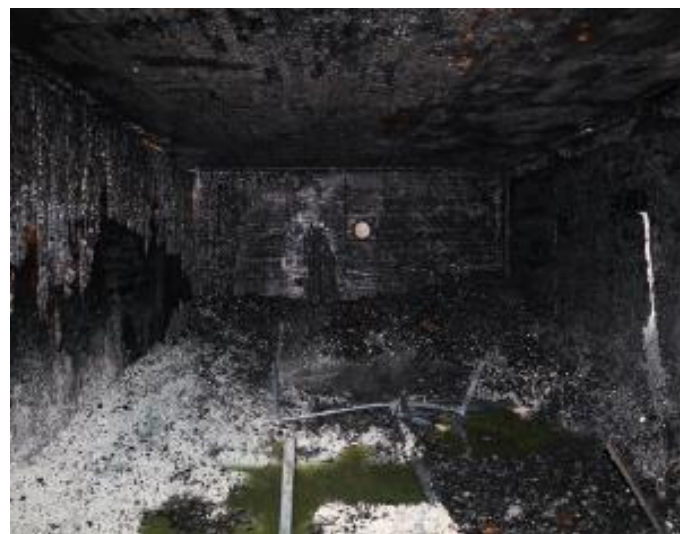
Figure 5. NRC FPRF CLT compartment fires [21]

a) Test 1-1 compartment after test

b) Test 1-2 condition of CLT after test

c) Test 1-2 CLT repaired with plywood

d) Test 1-3 charring of compartment

e) Test 1-4 charring of compartment

f) Test 1-5 charring of compartment

NRC conducted six large-scale CLT compartment fire tests in 2017 and 2018 at the National Institute of Standards and Technology (NIST) to assess the contribution of mass timber elements to compartment fires [21]. Images of the tests are shown in Figure 5. This work was initiated by the National Fire Protection Association NFPA Fire Protection Research Foundation (FPRF). The tests involved varying the location and degree of exposed timber elements without the installation of sprinklers or firefighter intervention. Tests lasted between 1 ½ to 4 hrs. Using gypsum board to encapsulate CLT elements was effective at delaying or preventing ignition of wood.

Test 1-1 was a baseline for comparison and used three layers of 15.9 mm (¾ in) Type X gypsum board. After the test all of the gypsum was removed and there was no damage to the structure, but there was minor smoke deposition on the exterior corners at the wall-ceiling junction which may have been prevented had the joints been sealed (Figure 5 a). In Test 1-2, where two layers of gypsum were used, one layer remained on the ceiling and both layers were still in place on the walls at the end of the test. No char developed on the walls, only some smoke deposition. There was surface charring on the ceiling, ranging from 0 – 15 mm, with deeper char evident at joint and CLT joints. There were two localized spots of 50 mm deep charring: in a mid-ceiling joint, and in a ceiling corner. Sealing of the joints would have likely reduced charring at these two locations. To reuse the structure for the Test 1-3, the two locations of deep charred were chiselled out and plywood pieces were screwed in place. When the room was relined for the following test, longer screws were used to install the gypsum board on the ceiling because of some of the remaining surface char.

In Test 1-3 one wall was left exposed, all wall surfaces were protected with two layers of gypsum board and the ceiling with three. 85% of this wall charred up to the third ply, with a char depth of approximately 80 mm. Charring was less severe, 60 mm, close to the front window opening. For the remaining protected walls, W3 charred 35% of the surface to a maximum of 10 mm, W4 charred 50% up to 20 mm. The ceiling with three layers of gypsum generally did not char any more, except near the exposed wall up to 10 mm. There was some flame-through at joints 3 hrs into the test, which likely could have been delayed had the joints been sealed. In Test 1-4 the ceiling was left exposed and the walls protected with three layers of gypsum. Most of the ceiling lost more than two plies (70 mm), and 55% charred up to 90 mm. Two of the walls charred 25-40% up to 14 mm, and one wall only had 10% surface char. Test 1-5 had one exposed wall and three layers of gypsum on the other surfaces, it ran for nearly 3 ½ hrs. All of the surfaces charred (Figure 5 g). The exposed wall charred up to 141 mm, the ceiling 79 mm, and 52 mm in the other walls. In the final test, Test 1-6, the entire ceiling and one wall were exposed and it ran for 2 ½ hrs. The exposed ceiling and wall charred up to 154 mm, and the other walls charred up to 68 mm.

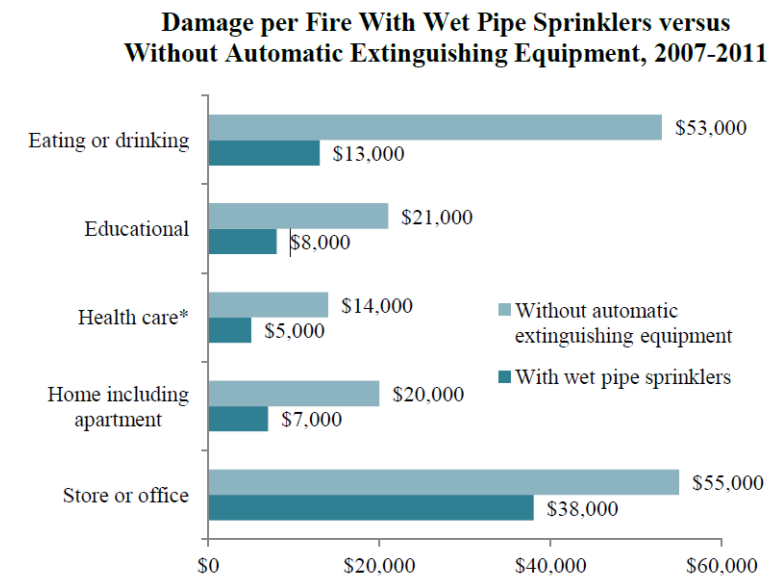
Figure 6. Damage in fires with and without sprinklers [29]

If a sprinkler is effective, then a fire was controlled and was not able to grow, therefore limiting potential overall fire damage. Damage per fire can be 70% less when sprinklers are in use, compared to a similar unit without sprinklers which may reach flashover conditions and its fully-developed stage [28]. Figure 6 provides a comparison in the costs (in USD) of damage in instances with and without wet pipe sprinklers; in some cases as much as 75% less. If a sprinkler system extinguishes a fire, this eliminates the need for use of fire hoses.

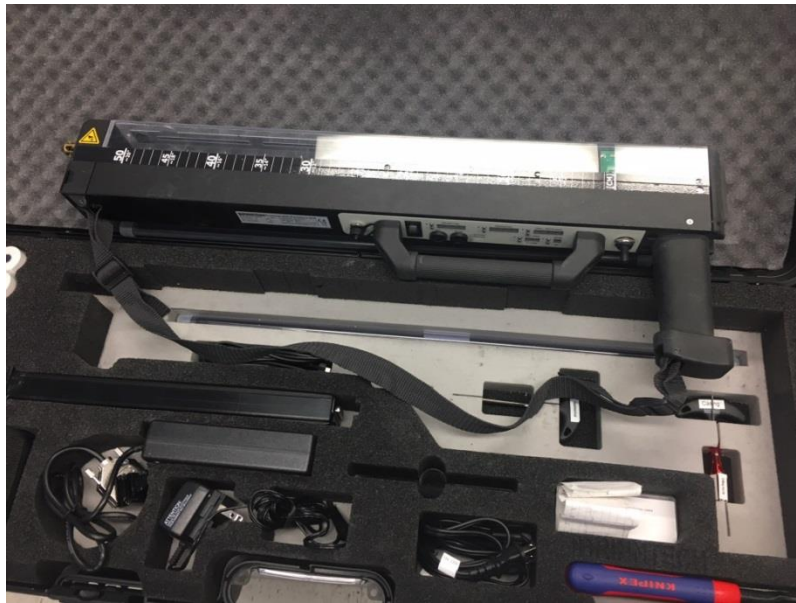
Figure 7. Resistograph®

The Resistograph® [51] is a commercially available micro-drilling tool, shown in Figure 7. A Resistograph® was used to evaluate the residual depth of nail-laminated timber (NLT), dowel-laminated timber (DLT), X-Laminated Veneer Lumber (X-LVL), and glued-laminated timber (GLT) assemblies [52] [53]. The assemblies also had sections cut after the fire, or were visually inspected, to determine the residual depth of the section. The visual measurements simply determined the residual depth of the section based on the interface between charred and

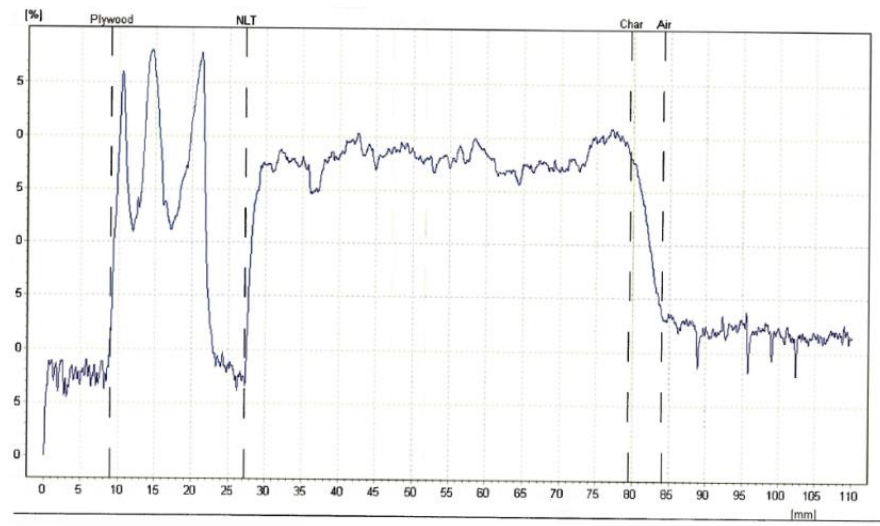
Figure 8 Resistograph® plot of NLT exposed to fire

uncharred wood. The visual measurements were generally in agreement with the Resistograph® measurements, within +/- 10 mm. Figure 8 is a resistance plot of a 2x6 NLT floor after 100 min exposure to a standard fire. The assembly had one layer of 12.7 mm (½ in) plywood on the unexposed side of the assembly. The plot demonstrates that there are roughly distinct sections: air (on either side of the assembly), plywood, mass timber (NLT), and charred wood. Some of the sections are well defined by a roughly horizontal line, such as the uncharred wood, but the transition to char layer appears as more of a gradient. This could be a useful preliminary evaluation tool, but because of subjective interpretation of the plot, it should not be relied on to determine exact residual dimensions of an assembly.

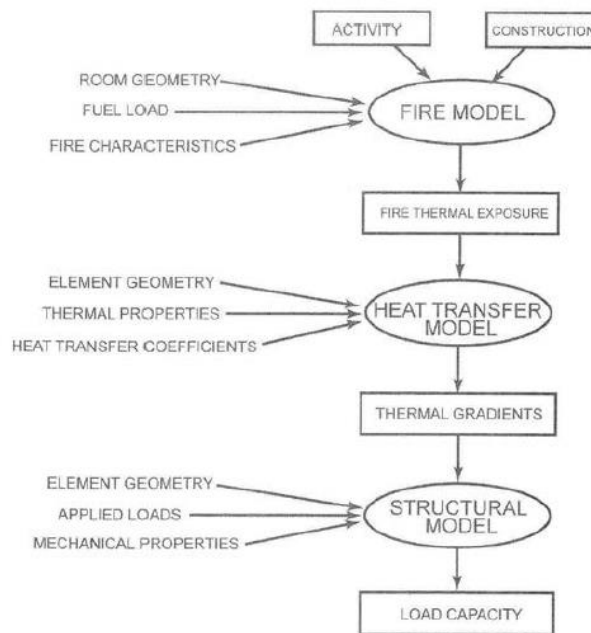
Figure 10. Flowchart for modeling fire-damaged wood members [58]

Fire modelling can be a useful tool to recreate a fire scenario to potentially assess the condition that wood elements might have been exposed to. Maximum temperatures in a fire can be estimated following the NFPA 921 Investigation protocol [57] or from fire modeling software (e.g. CFAST zone model or FDS using computational fluid dynamics). Once details of the fire environment are determined, a heat transfer model can be developed to determine thermal gradients within wood elements, and subsequent impact on structural capacity. A flowchart of the fire modelling process developed by Buchanan [58] is presented in Figure 10. Coupling thermal and structural models in computer modelling software, such as finite element modelling, can be challenging.

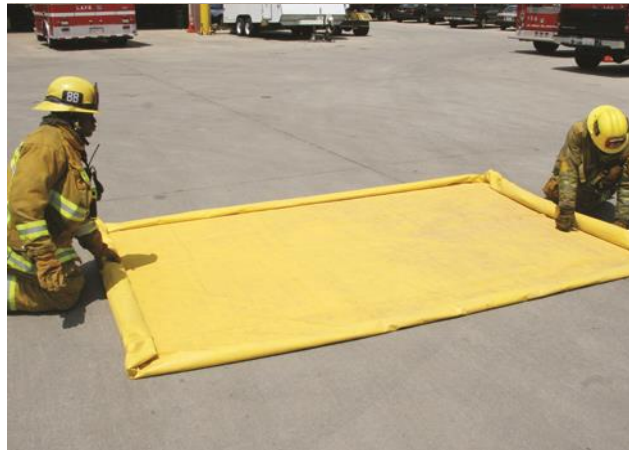
Figure 11. Catchall floor cover [68]

Hall or floor runners should be put down as firefighters enter the building to protect floors, carpets, and stairs from water and debris that could be tracked in. Personal contents on the floor below should be protected first with tarps and covers and the floor should be ‘bagged’, i.e. covered completely, and edges rolled. An example of a floor cover with rolled edges is shown in Figure 11. Cover edges can be raised on chairs, boxes, etc. to ensure water doesn’t overflow at edges. Edges can even be nailed to baseboards to prevent overflow.

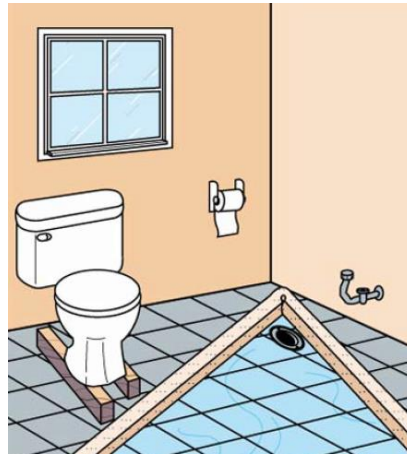
Figure 12. Routing water towards a toilet drain [69]

dumped into tub, showers, and sinks. An example of water being routed towards a toilet drain is shown in Figure 12. Residual water can be cleaned with wet/dry vacuums, squeegees, etc.

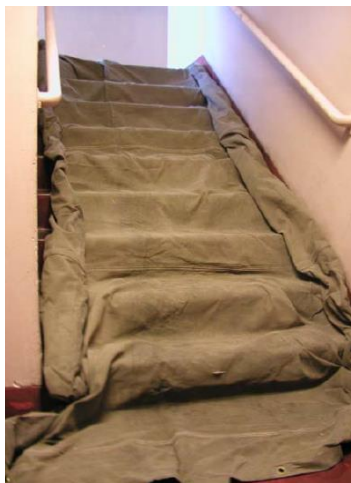
Figure 13. Use of salvage cover to protect and divert water down stairway [67]

Larger volumes of water can be moved to the ground level, then exterior, using stairways, elevator shafts, or chutes. In multi-storey buildings, it is not ideal to use exit stairways and elevator shafts because the water has a longer distance to travel and therefore more opportunities to cause damage. Waterproofing and proper drainage are more effective at reducing water damage [67]. When stairways are used the treads and risers should be protected with a cover, as shown in Figure 13. Note rolled edges to prevent overflow. Before water is moved using an elevator shaft, it is necessary to check if floor drains are open. If water does pool in a basement or elevator shaft, dewatering devices or pumps are used to move water. Protection should be provided at elevator openings in storeys below before water is moved. In a mass timber building it may be difficult to dry wood surfaces at the base of a shaft, whether elevator shafts should be used for salvage operations in mass timber buildings should be considered further. It may be prudent to provide alternative means to remove water from upper storeys.

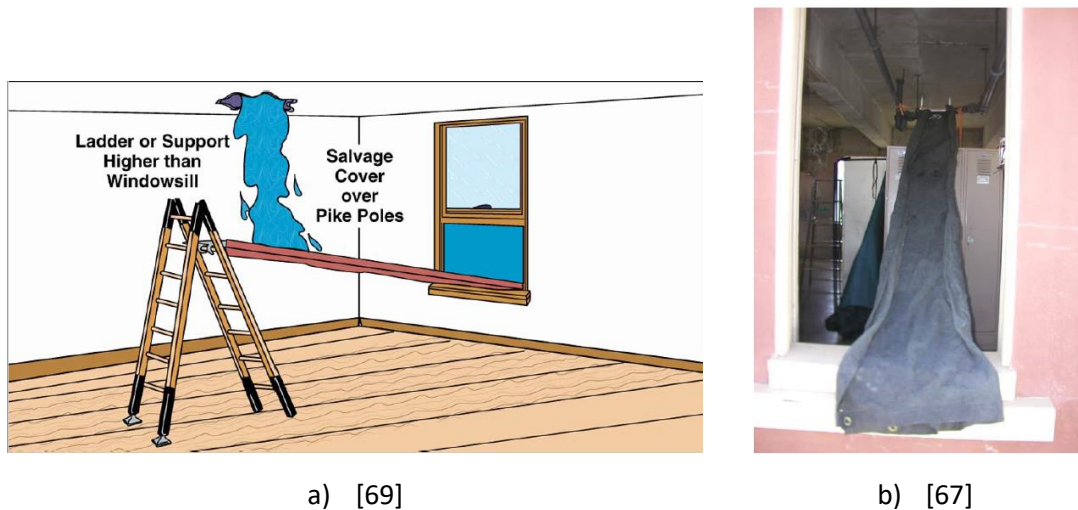
Figure 14. Routing water to exterior using chutes

In wood-frame construction there is an option to cut holes in floors and construct chutes on floors below to move water. This is only done when there is a large volume of water and there are insufficient drains or means to otherwise move the water. Examples of removal chute are shown in Figure 14. In this case, water can accumulate between floor and ceiling. It may be prudent to provide additional drains in mass timber construction, because cutting through the floor quickly is likely not an option.

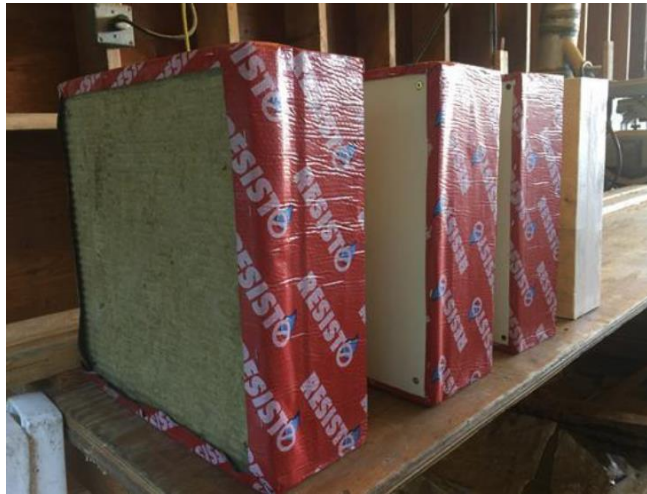
Figure 15. CLT specimens with gypsum board or mineral wool drying in shed [70]

FPIInnovations has conducted research on the drying performance of CLT elements, in particular relation to building durability during and after construction. Research on the wetting and drying performance of on-site moisture protection for CLT confirmed that moisture is slow to penetrate into the wide surface of CLT, whereas CLT edges are more susceptible to moisture absorption due to end grain exposure [70]. This research also looked at drying rates of wet CLT after being covered with drywall or 38 mm thick rigid mineral wool insulation. CLT was wetted through outdoor exposure for one month and then samples were left to dry in a shed (damp exterior conditions). The mineral wool insulation had a negligible impact on drying capacity. One layer of 12.7

mm ( $\frac{1}{2}$  in) thick drywall reduced drying rates by 20%, and three layers reduced the drying rate by 50%. This slowed drying confirms that any wetted wood should be dried before recovering. The moisture content measured 6 mm below the CLT surface, mostly remained below 20%. In an enclosed building, lower humidity (through space heating or dehumidifiers) would likely speed up drying rates.

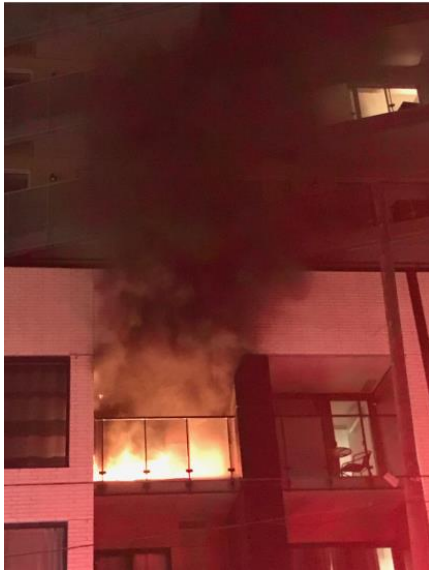
a) Fire

In October 2018, a fire broke out on a third storey balcony at one of the Arbora buildings in Montreal, QC. The building is a 8-storey mass timber building above a 1-storey concrete podium. Arbora consists of three similar buildings, which currently makes it the largest residential mass timber building complex in the world. Images from the fire, during exterior suppression, and damage after the fire are shown in Figure 16. The fire was confined to the balcony, but there was damage to the interior after a window broke. Interior damage from the fire was limited, but water did enter the structure through the window. The structure and fire safety features were effective at preventing further fire spread.

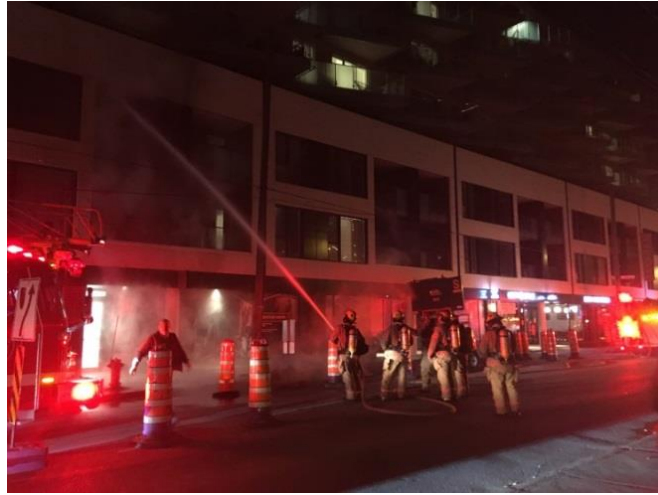
b) Hose application

Figure 16. Arbora fire Oct 2018

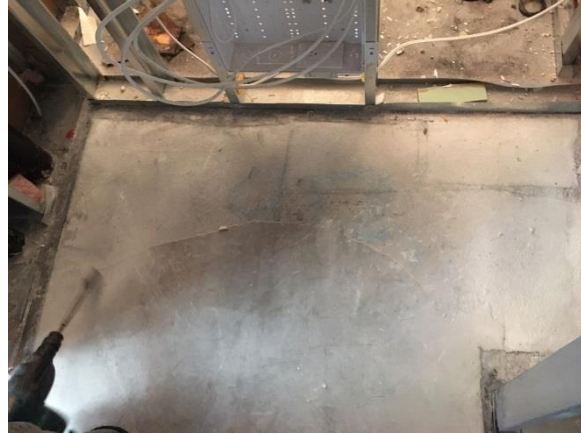
After the fire, all residual water was cleaned up and any affected gypsum board within the compartment was removed, as shown in Figure 17. Flooring in the affected area was also removed. A cut was made in the concrete topping to assess whether any water had reached the mass timber substrate. It was determined that the temperature of the mass timber was at ambient (around 20°C) and moisture content was between 12-13%. This suggests that water from suppression did not penetrate the concrete slab and the mass timber was not adversely affected. The prompt removal of water following the fire, and the presence of a concrete topping prevented water from reaching the mass timber beneath.

b) Condition of slab after water removal

Figure 17. Arbora unit rehabilitation

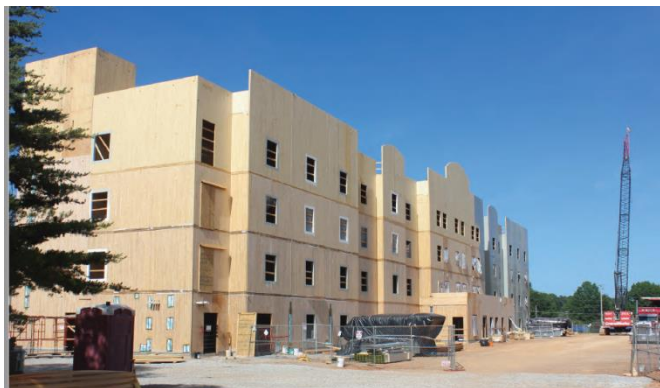
The Redstone Arsenal Building is a hotel constructed on a military base, in Huntsville, AL. The building is shown in Figure 18. It used over 1200 CLT panels, as well as wood beams and columns. The CLT exterior walls are 125 mm thick and the CLT floor was 175 mm thick. All walls are protected with gypsum board. During construction in 2016, an electrical fire occurred in the basement during the electrical panel installation [76]. Damage was essentially limited to the electrical equipment, with minor damage was sustained to gypsum walls in the electrical room. The fire was quickly suppressed and the CLT itself was never exposed to flames. Because of the security of this building (because it is on a military base), interior images could not be shared. This example suggests that fires can be adequately controlled in mass timber buildings and fire damage to the structure can be limited or minimal with adequate protection.

Figure 18. Redstone Arsenal hotel under construction (photo credit LendLease) [77]
